# Village of Wheeling

## Benchmark Locations

BenchmarkMap\_8.5x11\_20170131  
JVD, Jan. 31st 2017

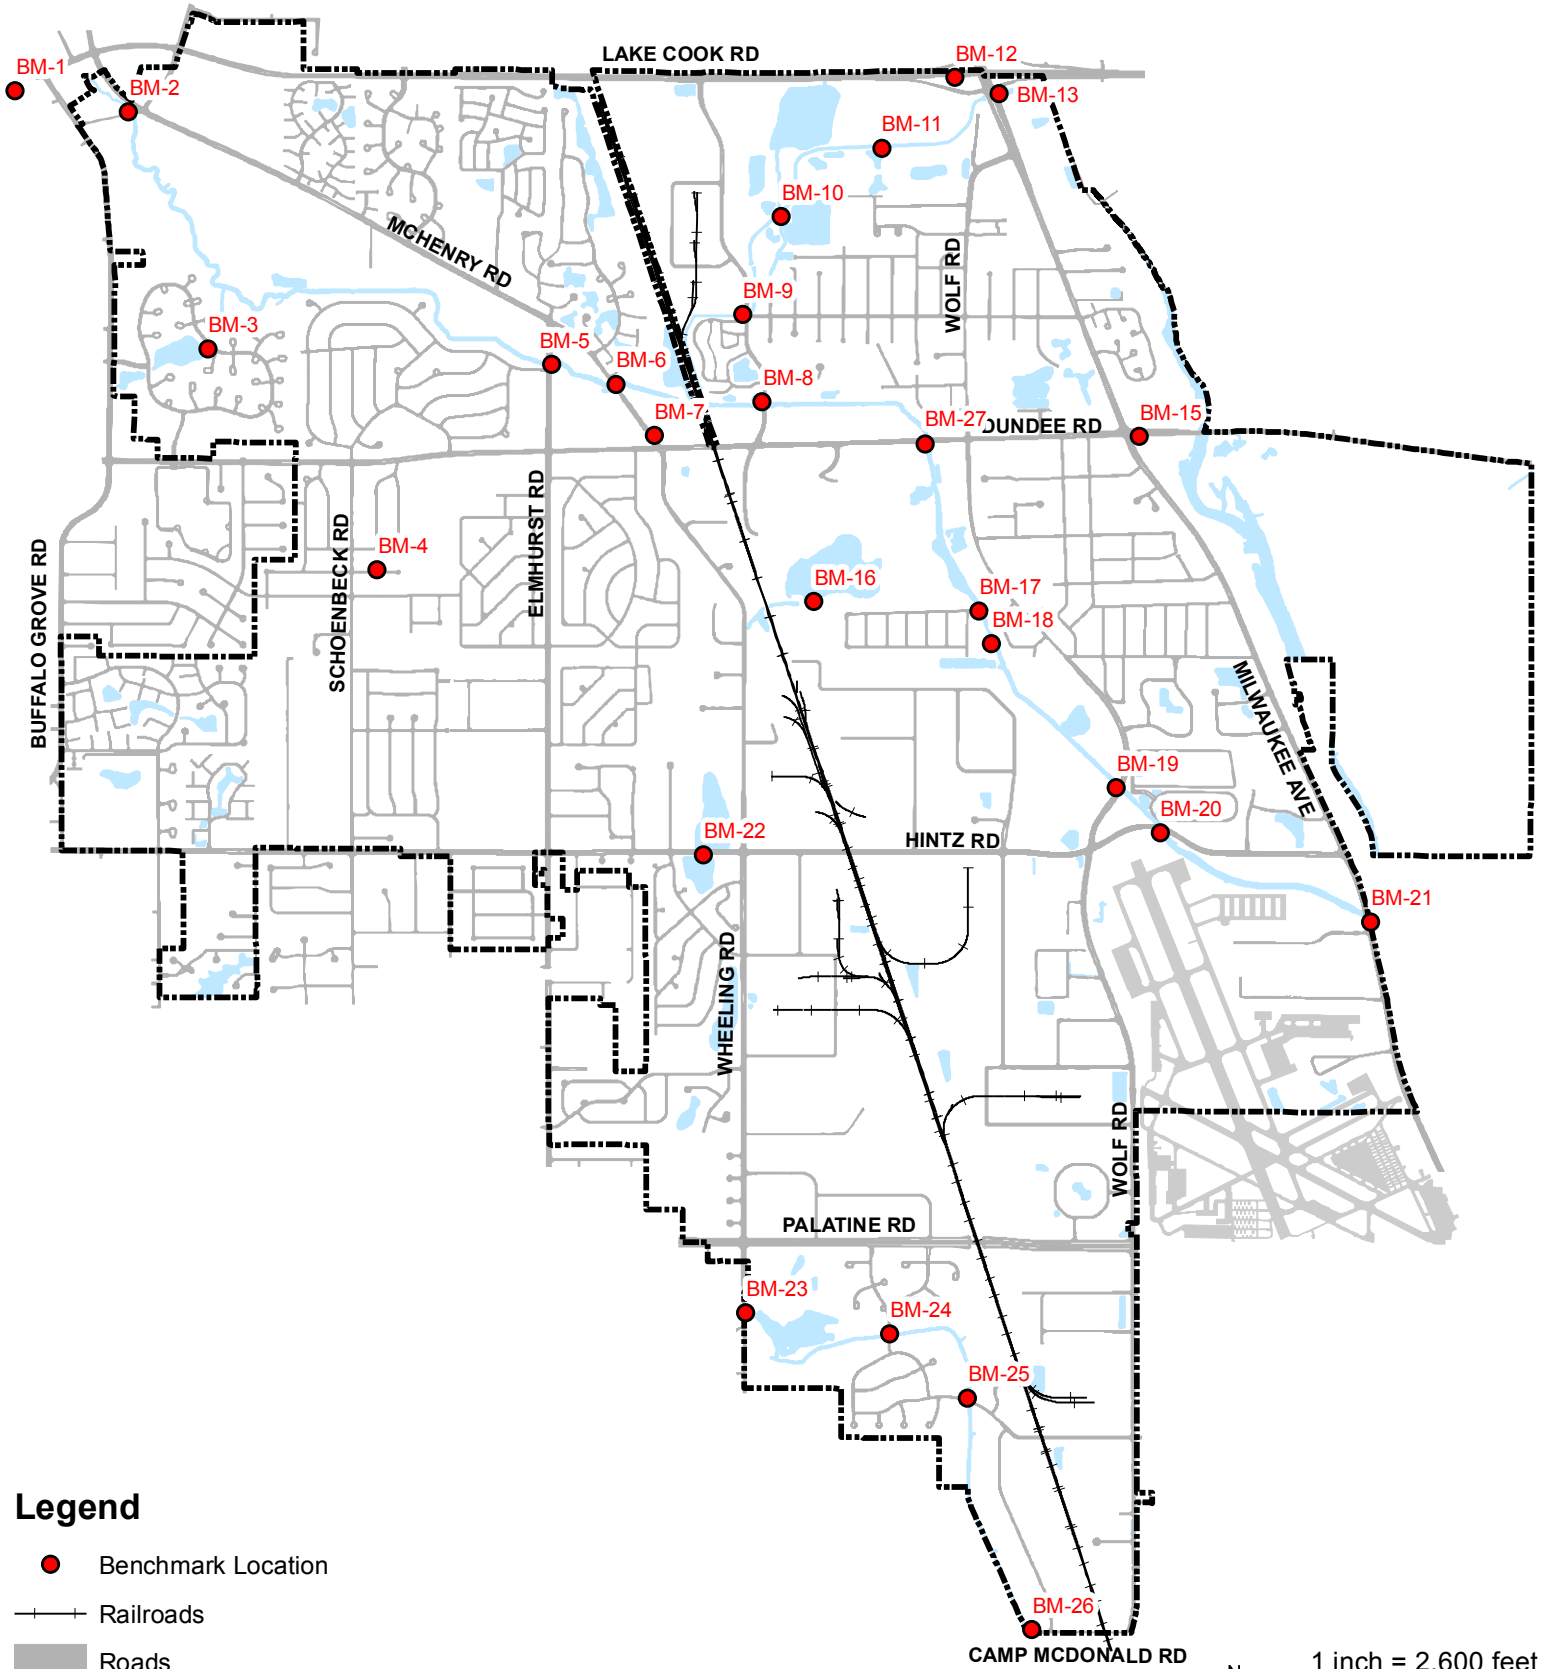
- Legend**
- Benchmark Location
  - +— Railroads
  - Roads
  - Pond or River
  - ⋯ Village Limit

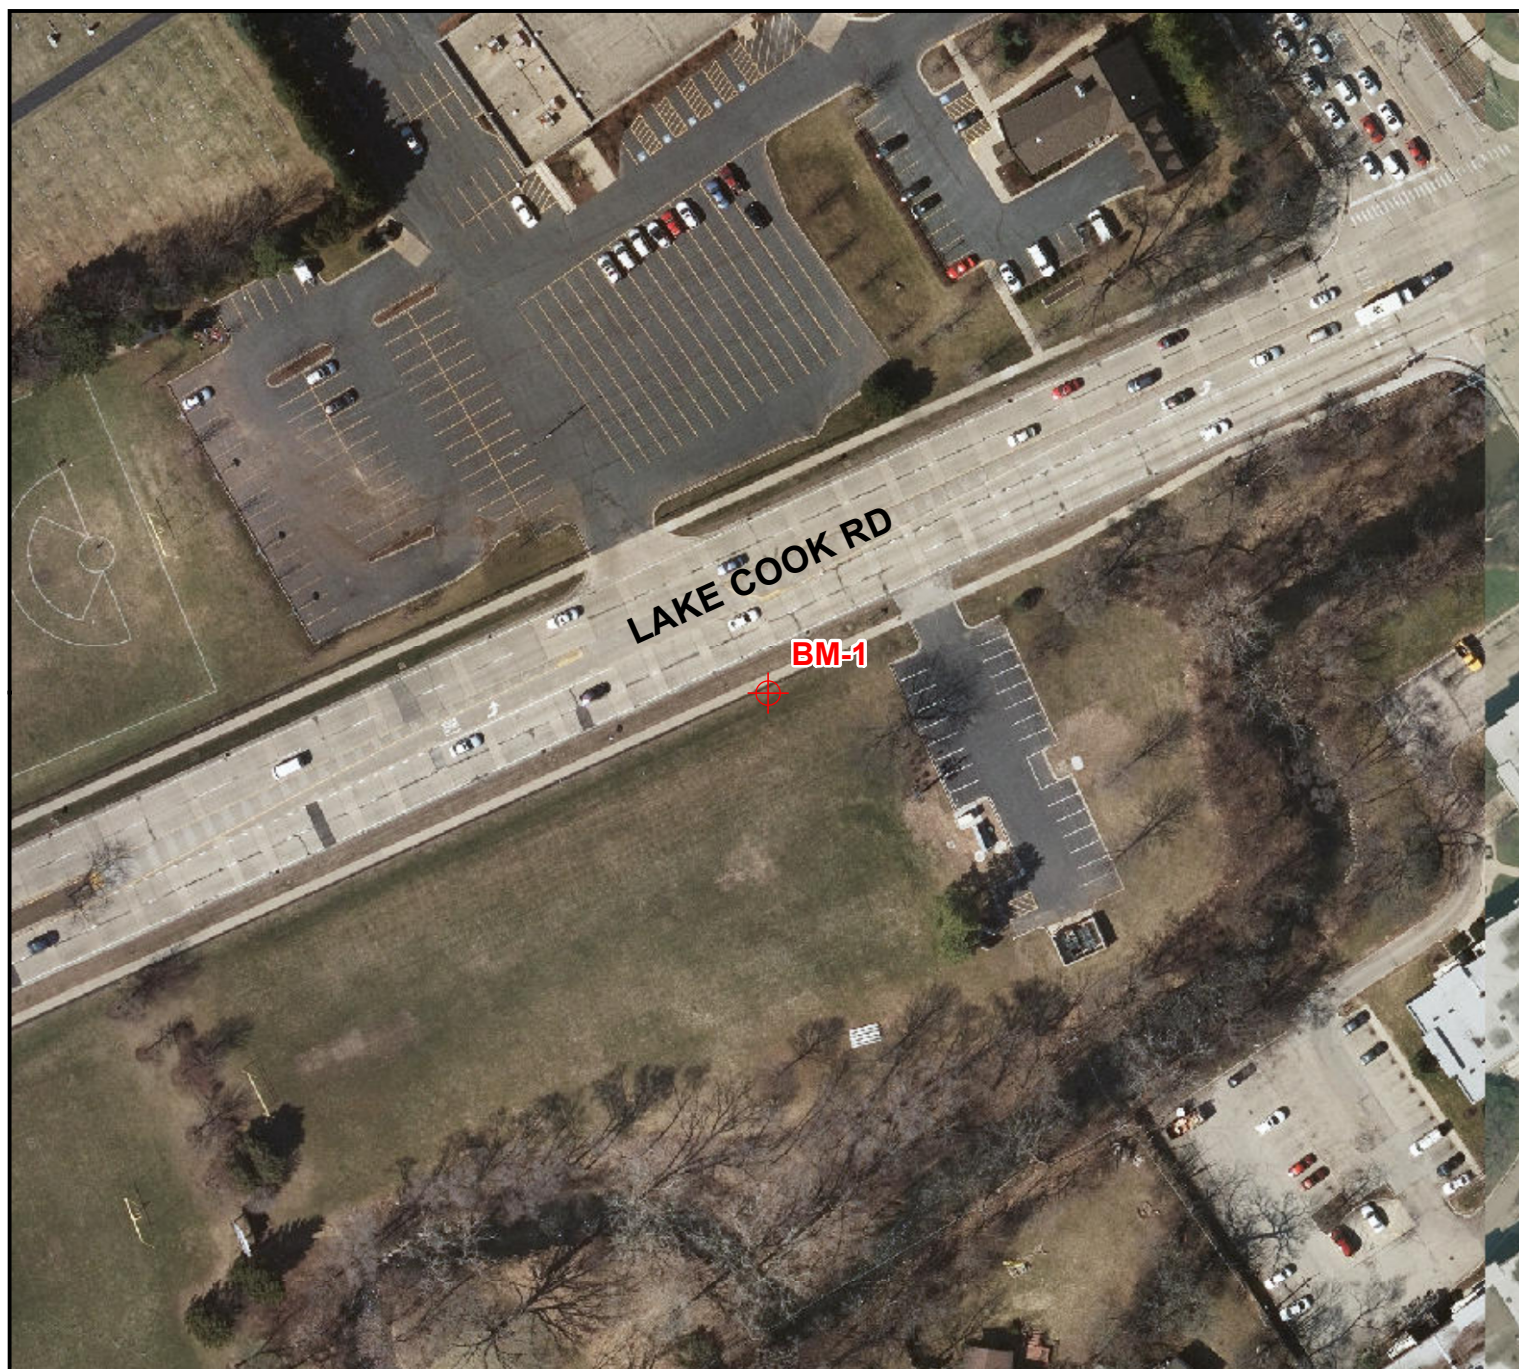
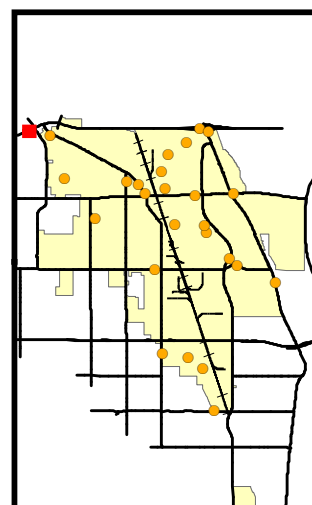
Benchmark BM-1  
Northing: 1998441.164  
Easting: 1084623.257  
Elevation: 675.999 FT  
Description: 3D Rod Monument Under Access Cover

Location: ~400 FT. SW of Lake-Cook Rd. & Buffalo Grove Rd.

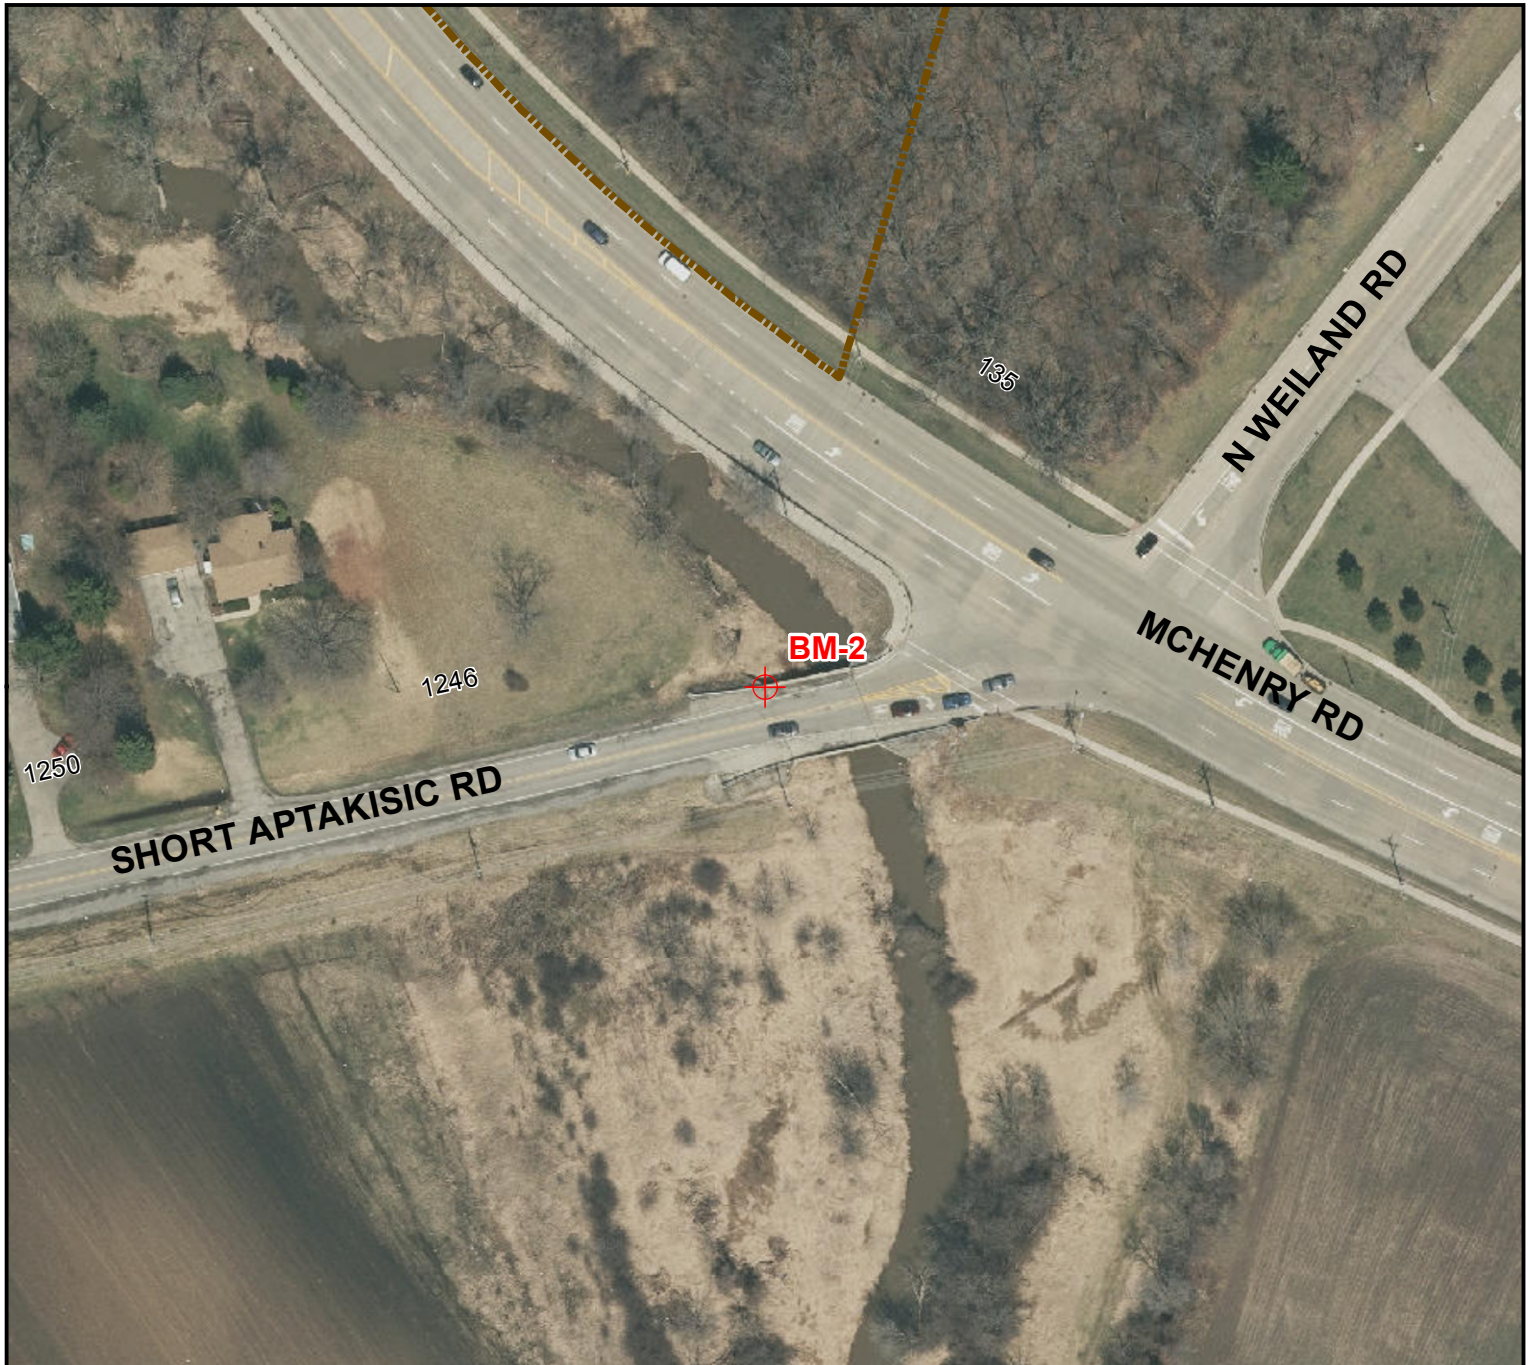
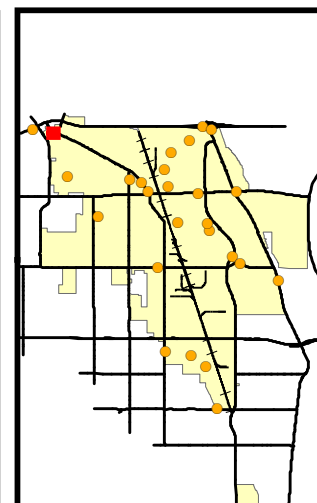
| Benchmark | BM-2 |

| Description: | Brass Disk, Stamped: USACOE Station "Buff-1", 1999 |
| Location: | NW Wingwall, Aptakismic Rd., 60' S. of McHenry Rd. |

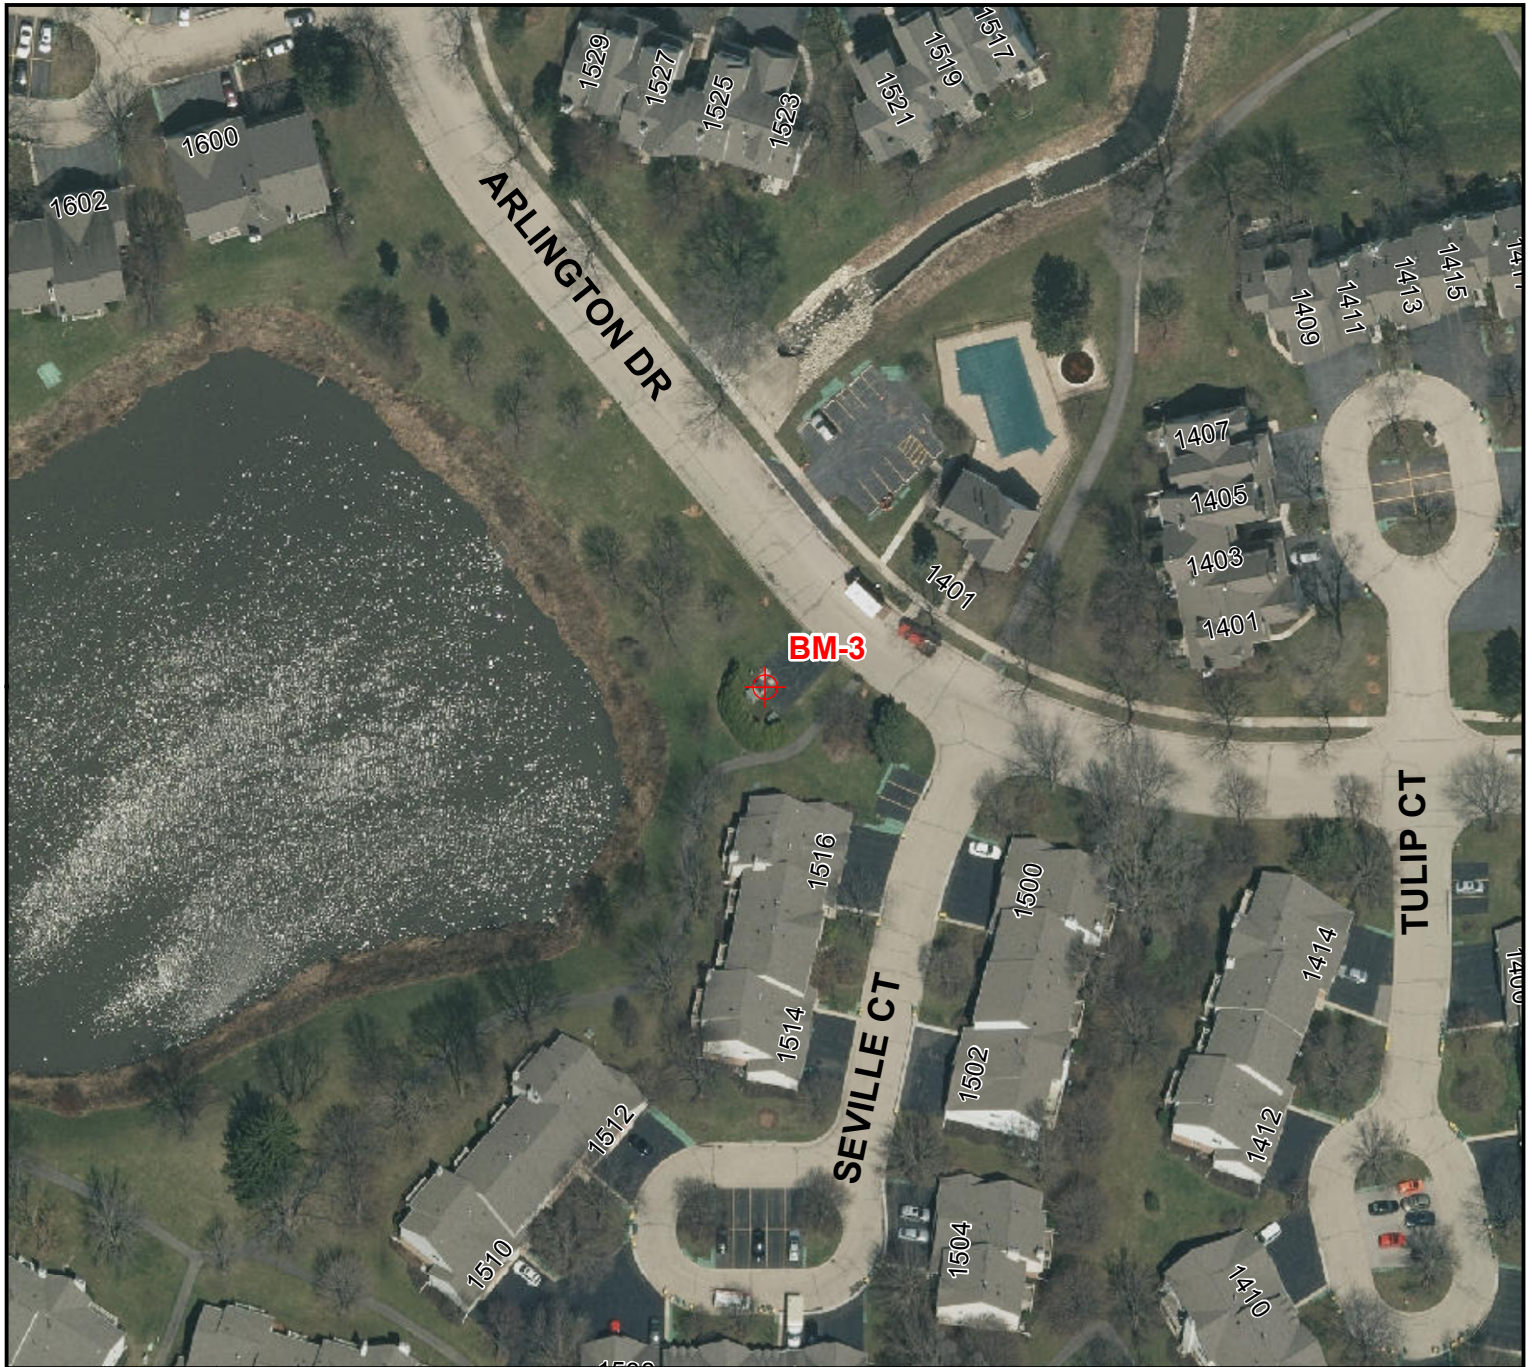
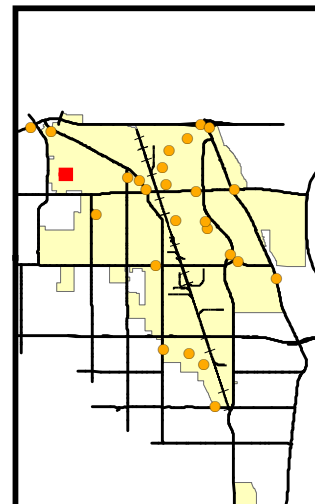
**Benchmark** BM-3  
**Northing:** 1994936.92  
**Easting:** 1087231.99  
**Elevation:** 669.849 FT  
**Description:** 2.5" Alluminum Disk Stamped  
Village of Wheeling - Survey Marker  
**Location:** San. Sewer Lift Station, NW Corner of  
Arlington Dr. & Seville Ct.

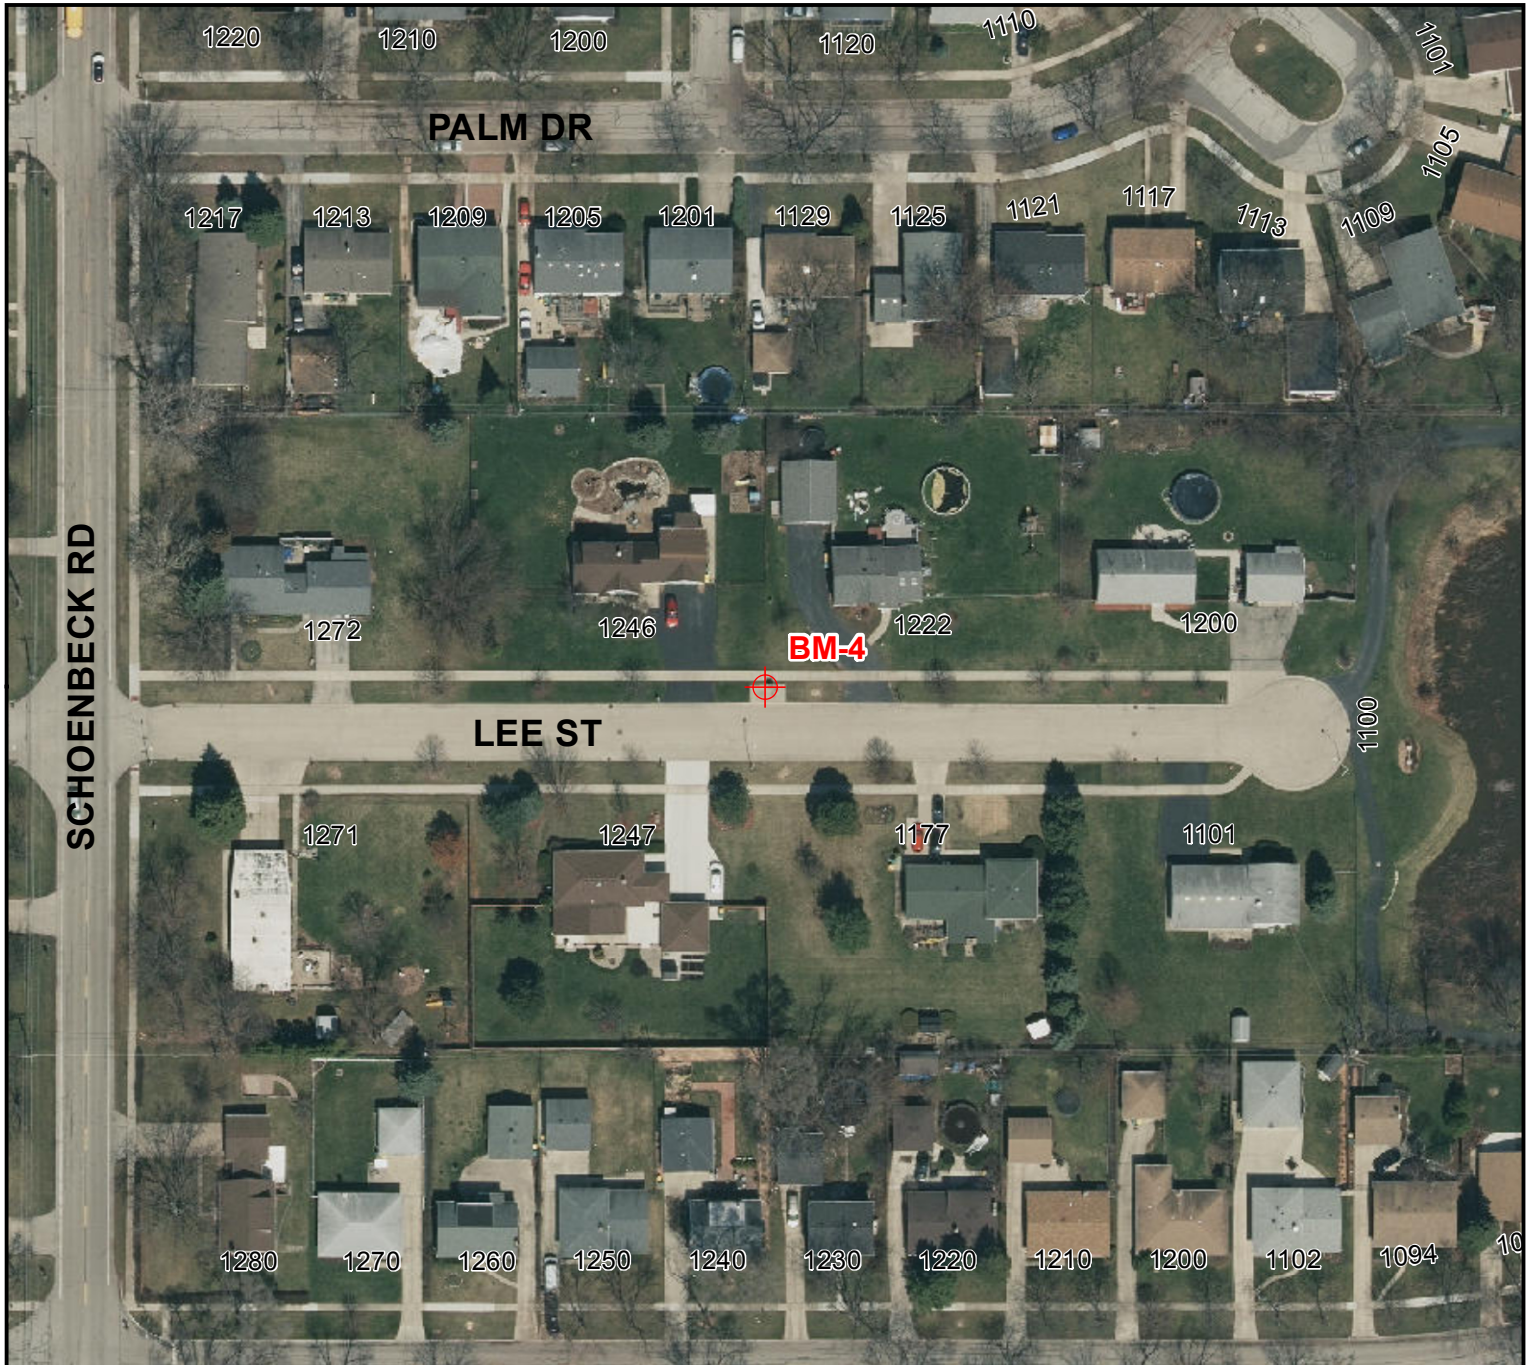
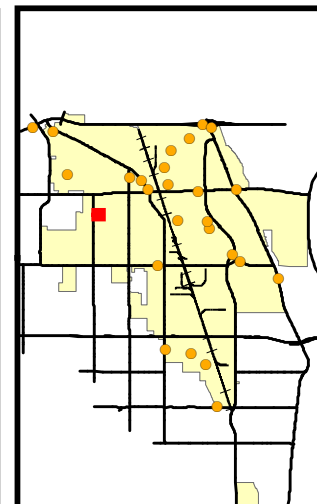
**Benchmark** BM-4  
**Northing:** 1991946.725  
**Easting:** 1089529.61  
**Elevation:** 655.274 FT  
**Description:** 2.5" Alluminum Disk Stamped  
Village of Wheeling - Survey Marker  
**Location:** N. Side of San. Sewer Lift Station

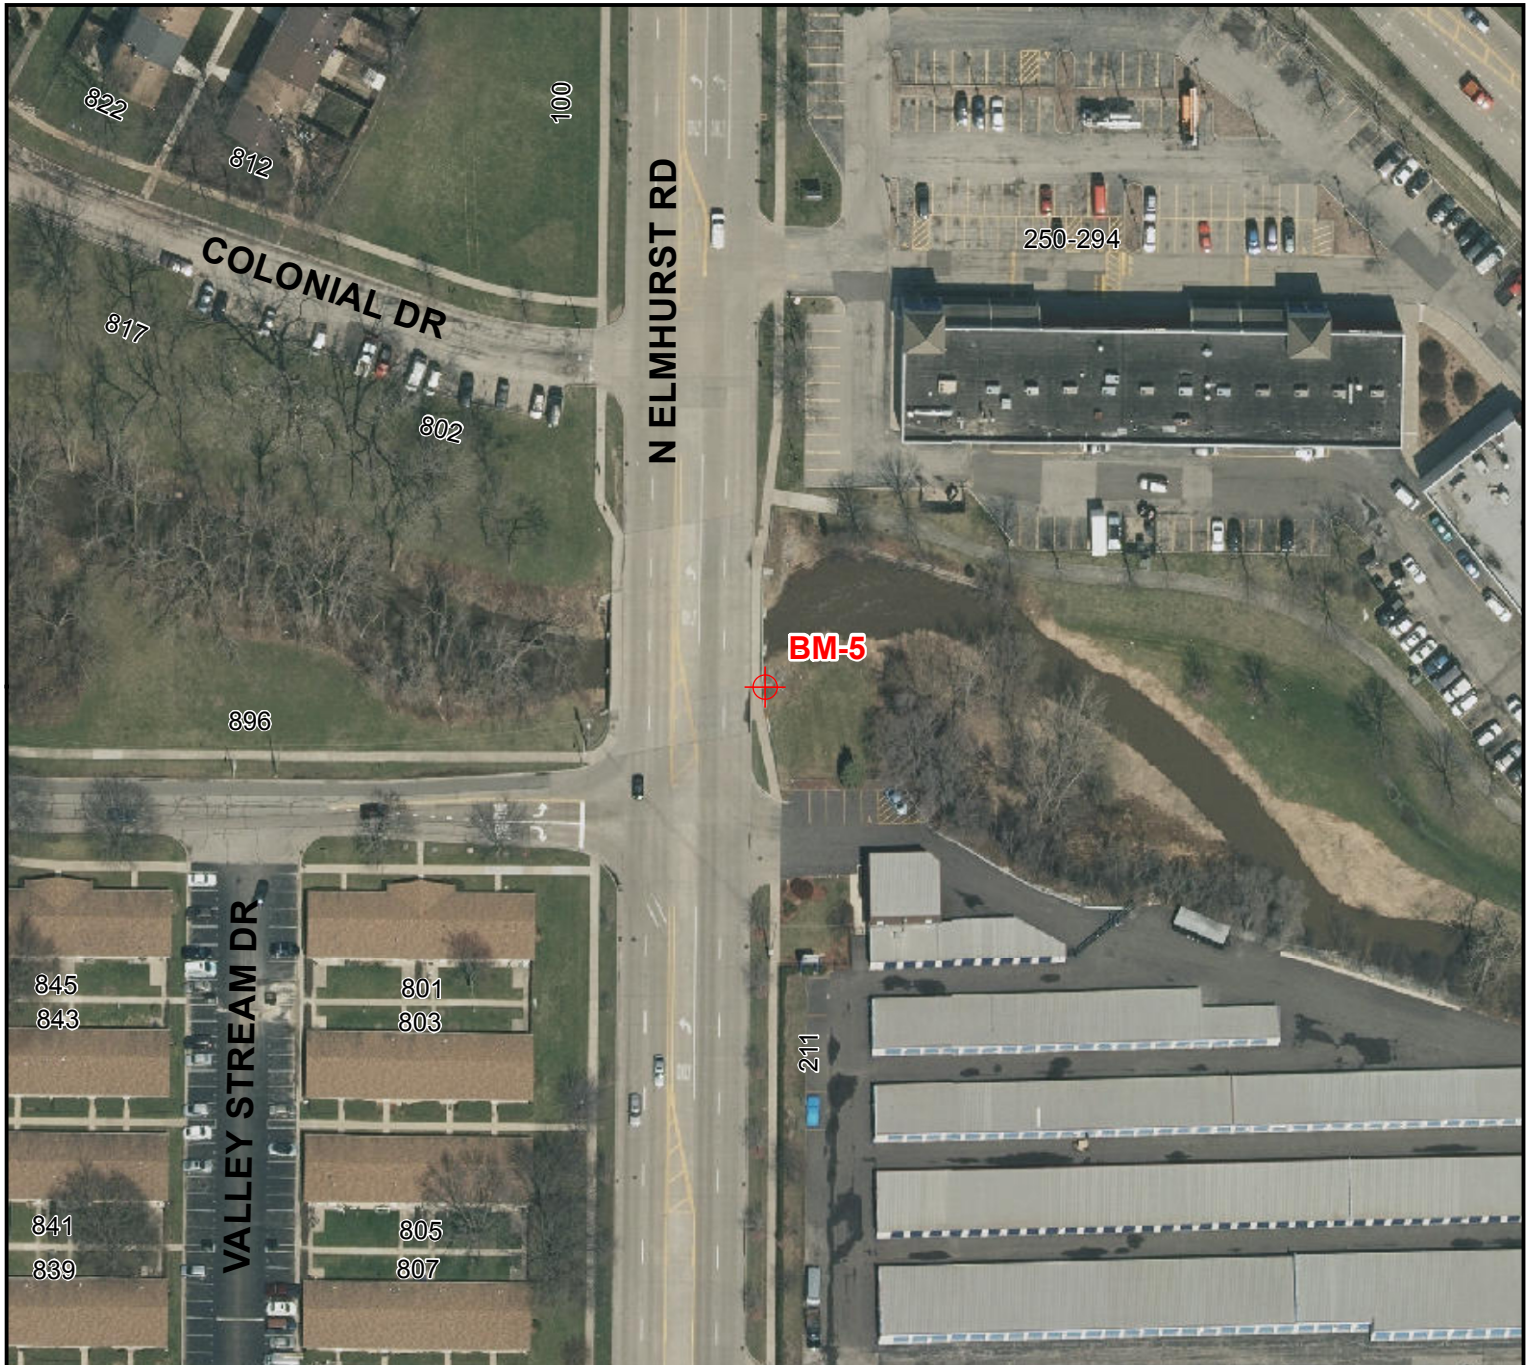
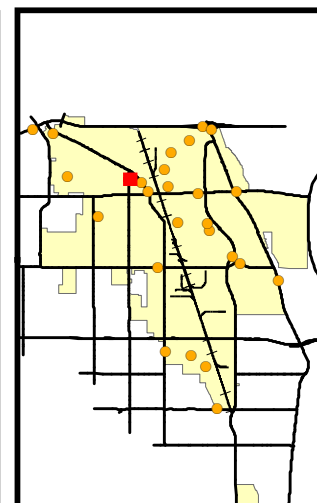
**Benchmark** BM-5  
**Northing:** 1994727.896  
**Easting:** 1091889.606  
**Elevation:** 655.145 FT  
**Description:** 2.5" Alluminum Disk Stamped  
Village of Wheeling - Survey Marker  
**Location:** SE Corner of Elmhurst Bridge, ~35' N.  
of Valley Stream Dr.

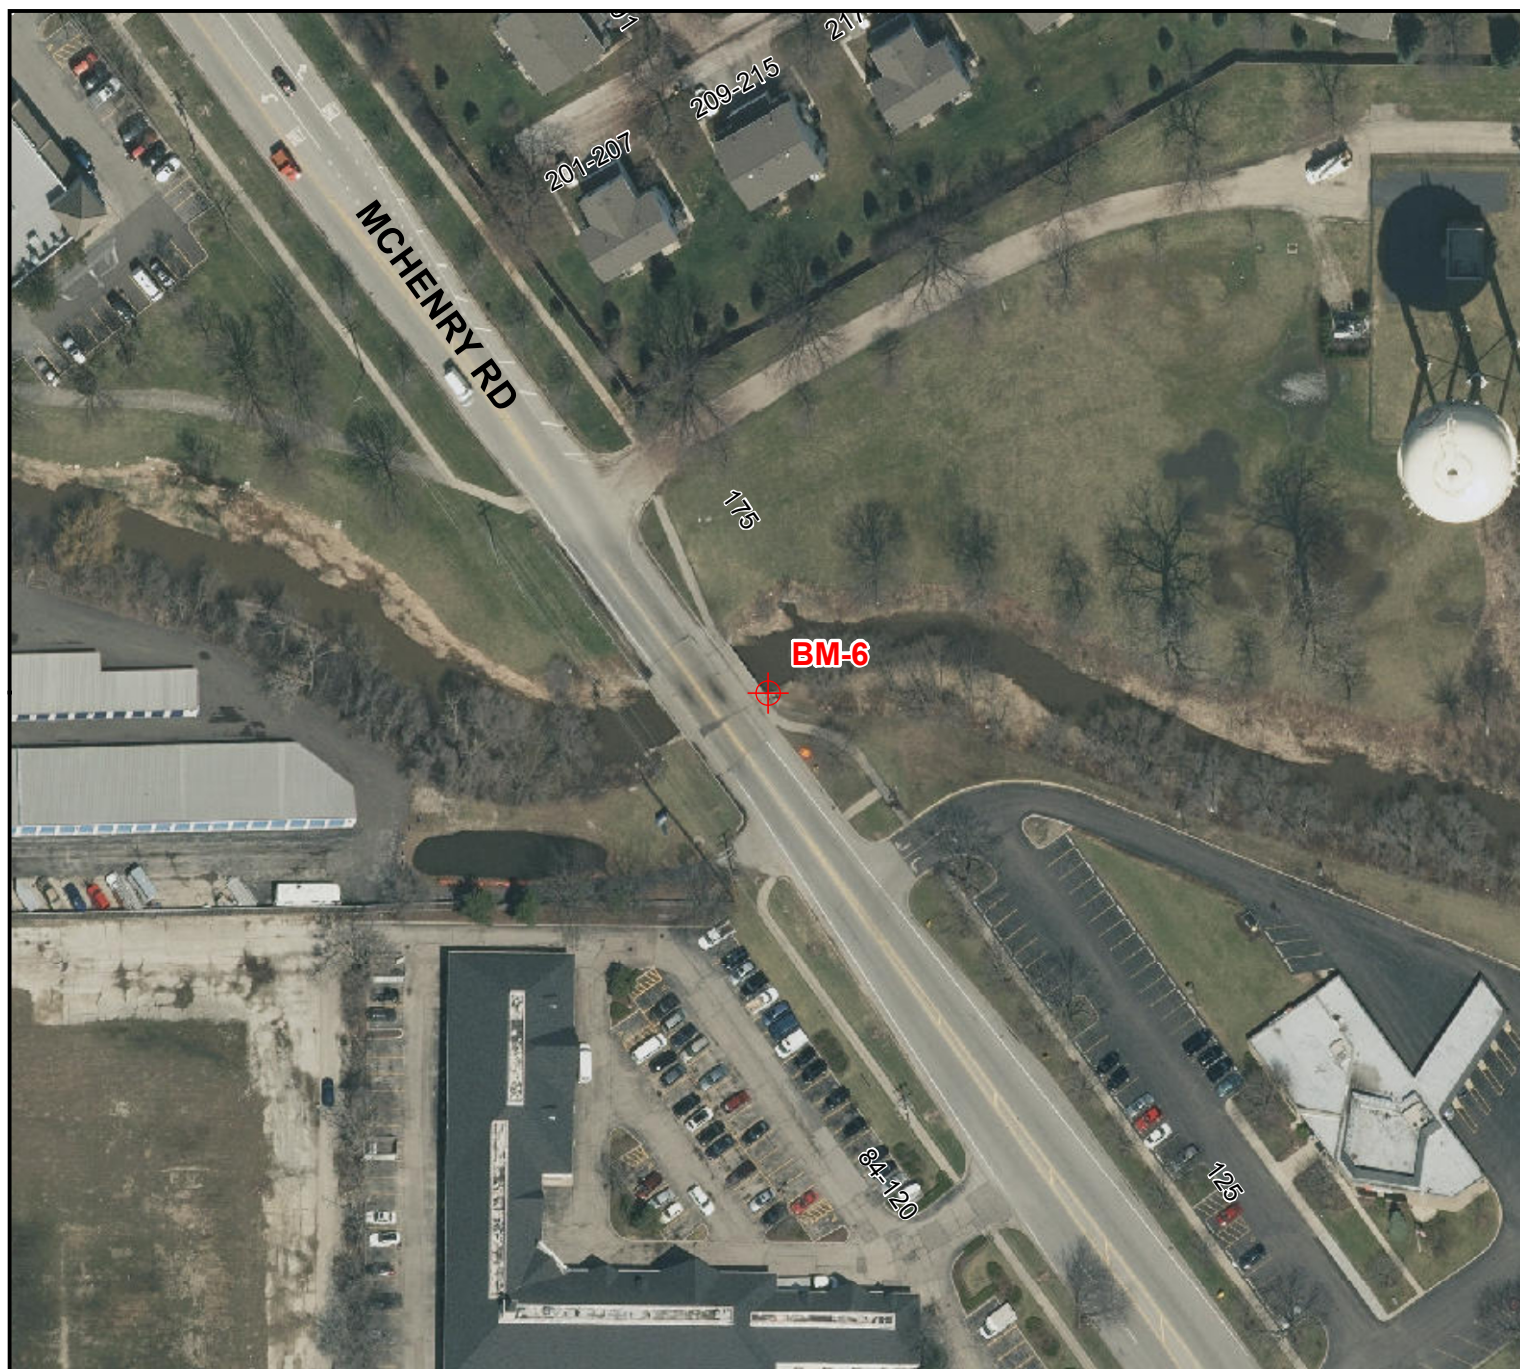
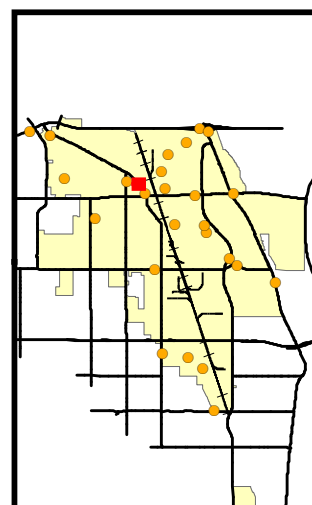
**Benchmark** BM-6  
**Northing:** 1994465.725  
**Easting:** 1092756.577  
**Elevation:** 653.563 FT  
**Description:** 2.5" Alluminum Disk Stamped  
Village of Wheeling - Survey Marker  
**Location:** SE Corner of McHenry Bridge, ~1000'  
N of Dundee

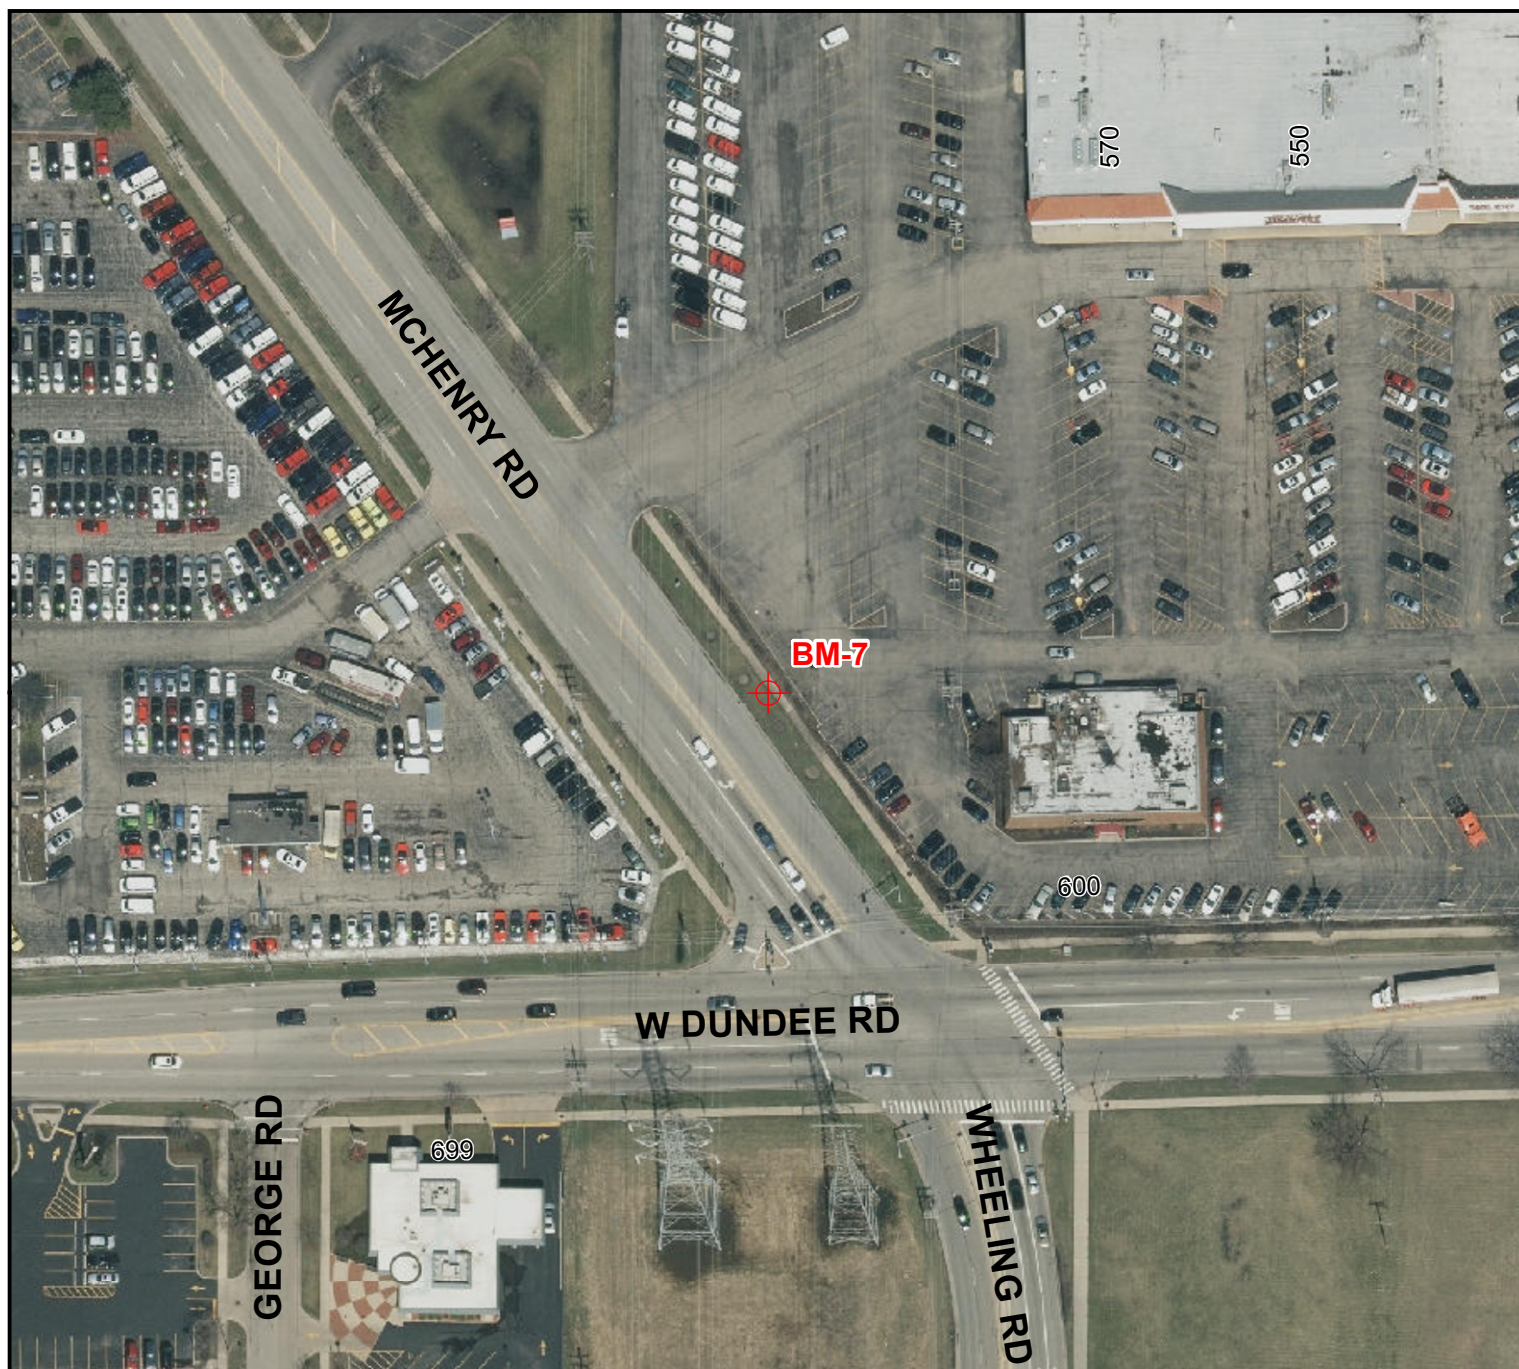
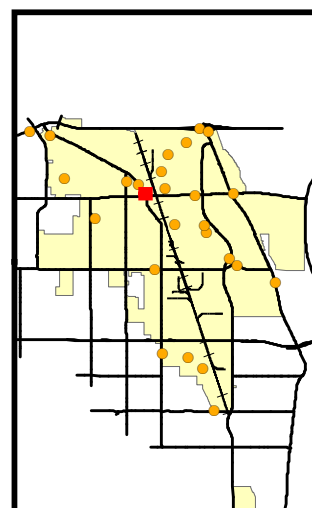
**Benchmark** BM-7  
**Northing:** 1993773.881  
**Easting:** 1093275.675  
**Elevation:** 649.184 FT  
**Description:** Brass Disk, Stamped: USACOE Station "Wheel-1", 1999  
**Location:** NW Wingwall Northgate Pkwy Bridge, ~530' N of Dundee Rd.

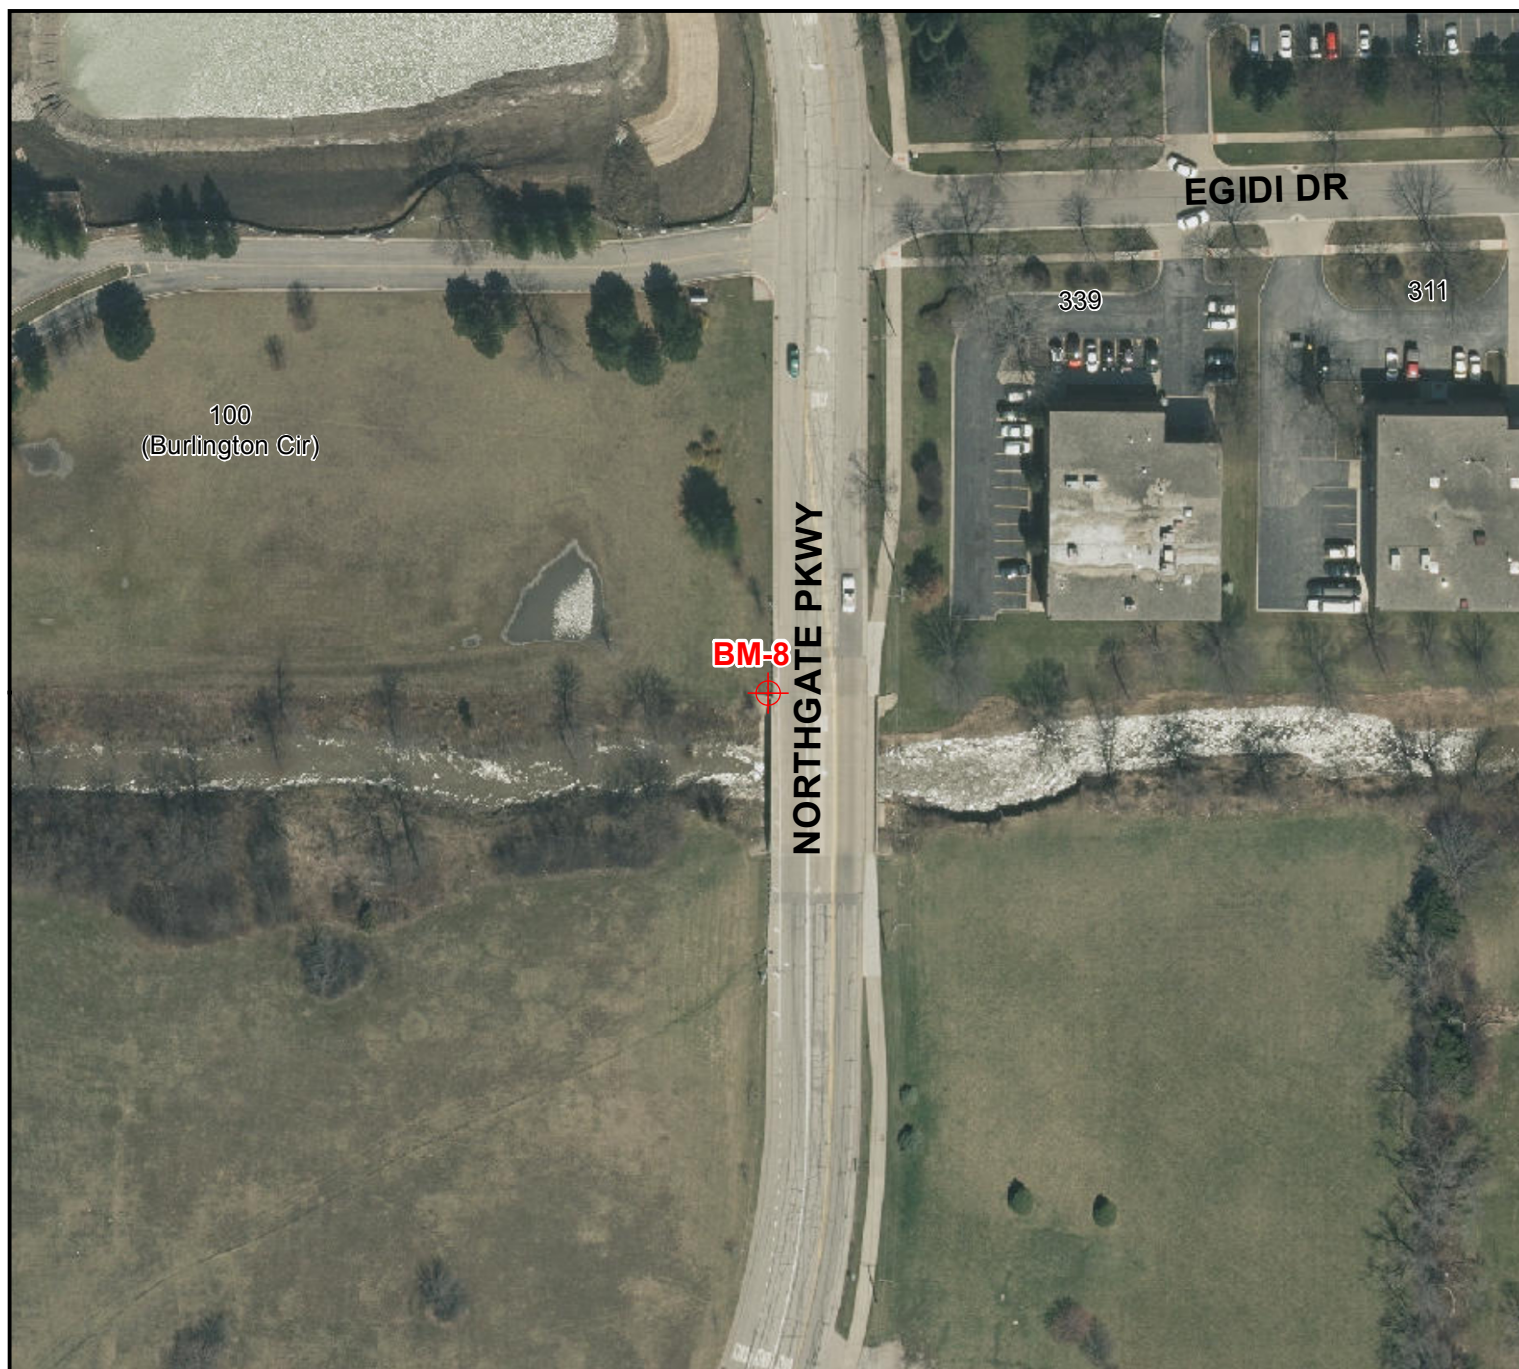
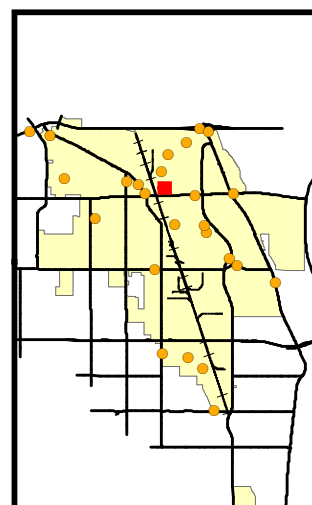
| Benchmark | BM-8 |

| Description: | Brass Disk, Stamped: Wheeling, National Geodatic Survey, 1956 1973 |
| Location: | W. Side McHenry Rd. ~160' N of Dundee Rd. |

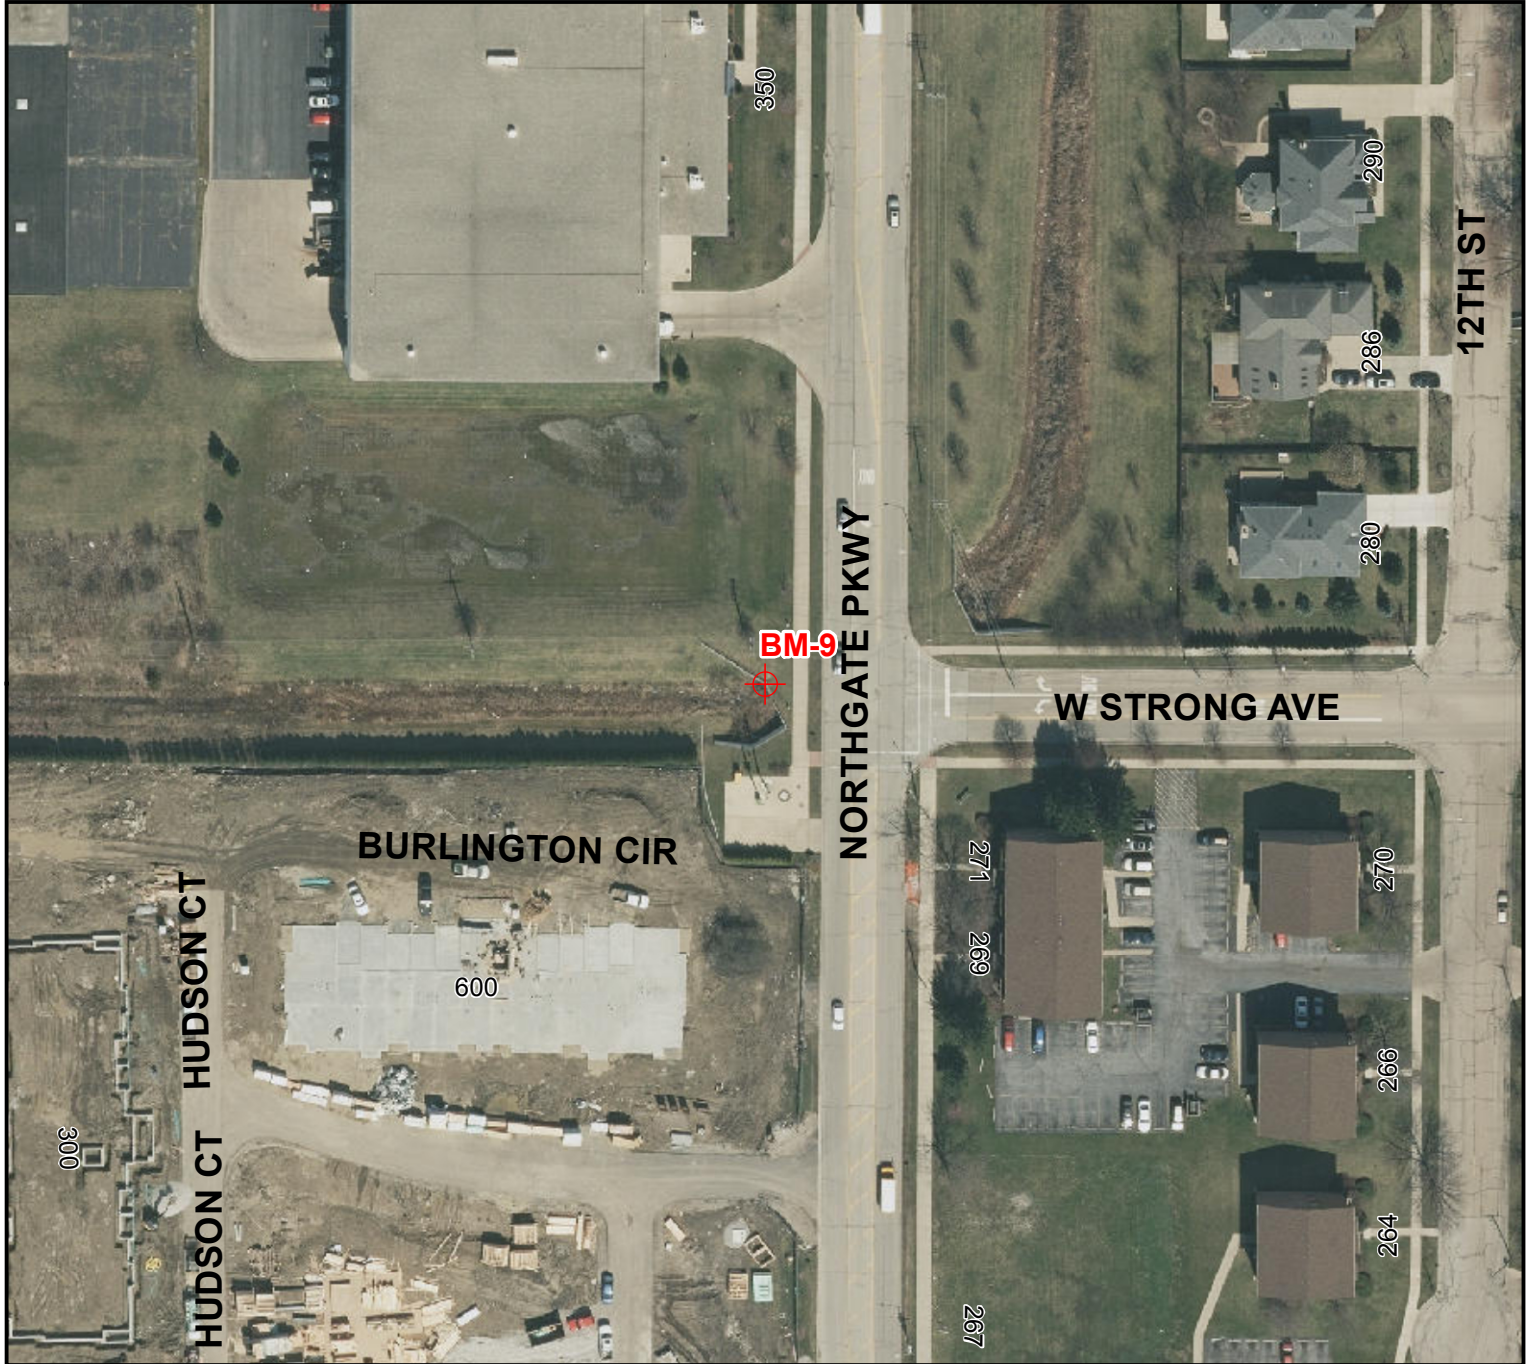
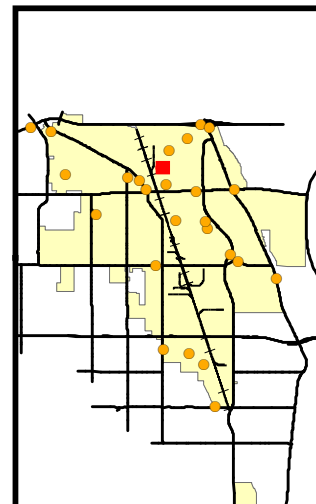
**Benchmark** BM-9  
**Northing:** 1995406.013  
**Easting:** 1094475.77  
**Elevation:** 647.521 FT  
**Description:** 2.5" Alluminum Disk Stamped  
Village of Wheeling - Survey Marker  
**Location:** N. Side of W. Wingwall, Northgate  
Pkwy Box Culvert
