# Village of Wheeling

## Benchmark Locations

BenchmarkMap\_8.5x11\_20170131  
JVD, Jan. 31st 2017

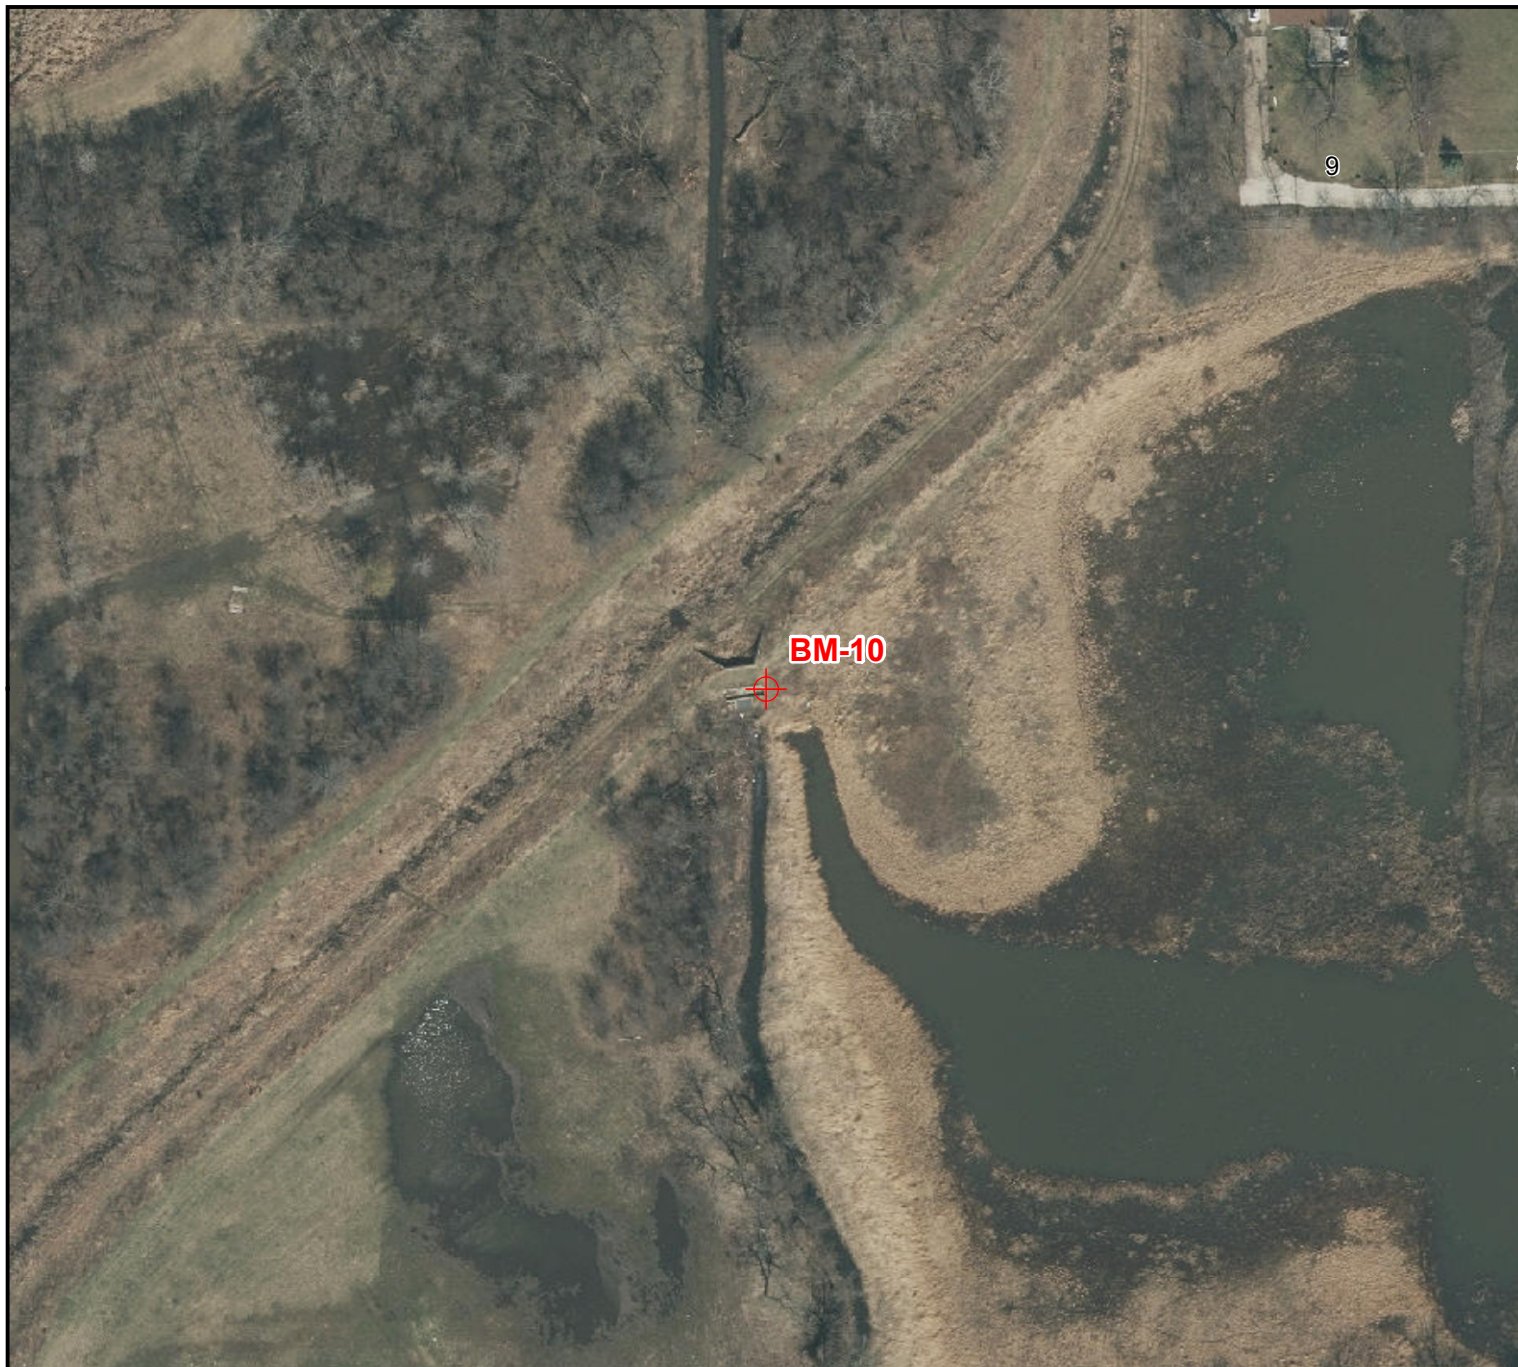
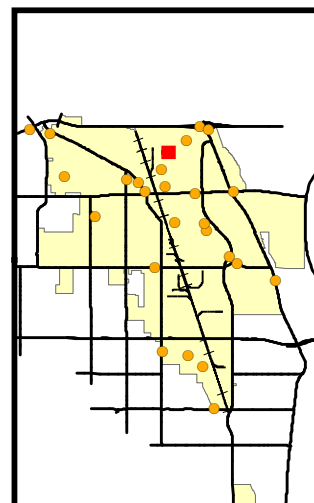
**Benchmark** BM-10  
**Northing:** 1996736.234  
**Easting:** 1094998.824  
**Elevation:** 644.553 FT  
**Description:** 2.5" Alluminum Disk Stamped  
Village of Wheeling - Survey Marker  
**Location:** Inverted Siphon Structure, ~575 Ft.  
NW of W. end of Mayer Ave.

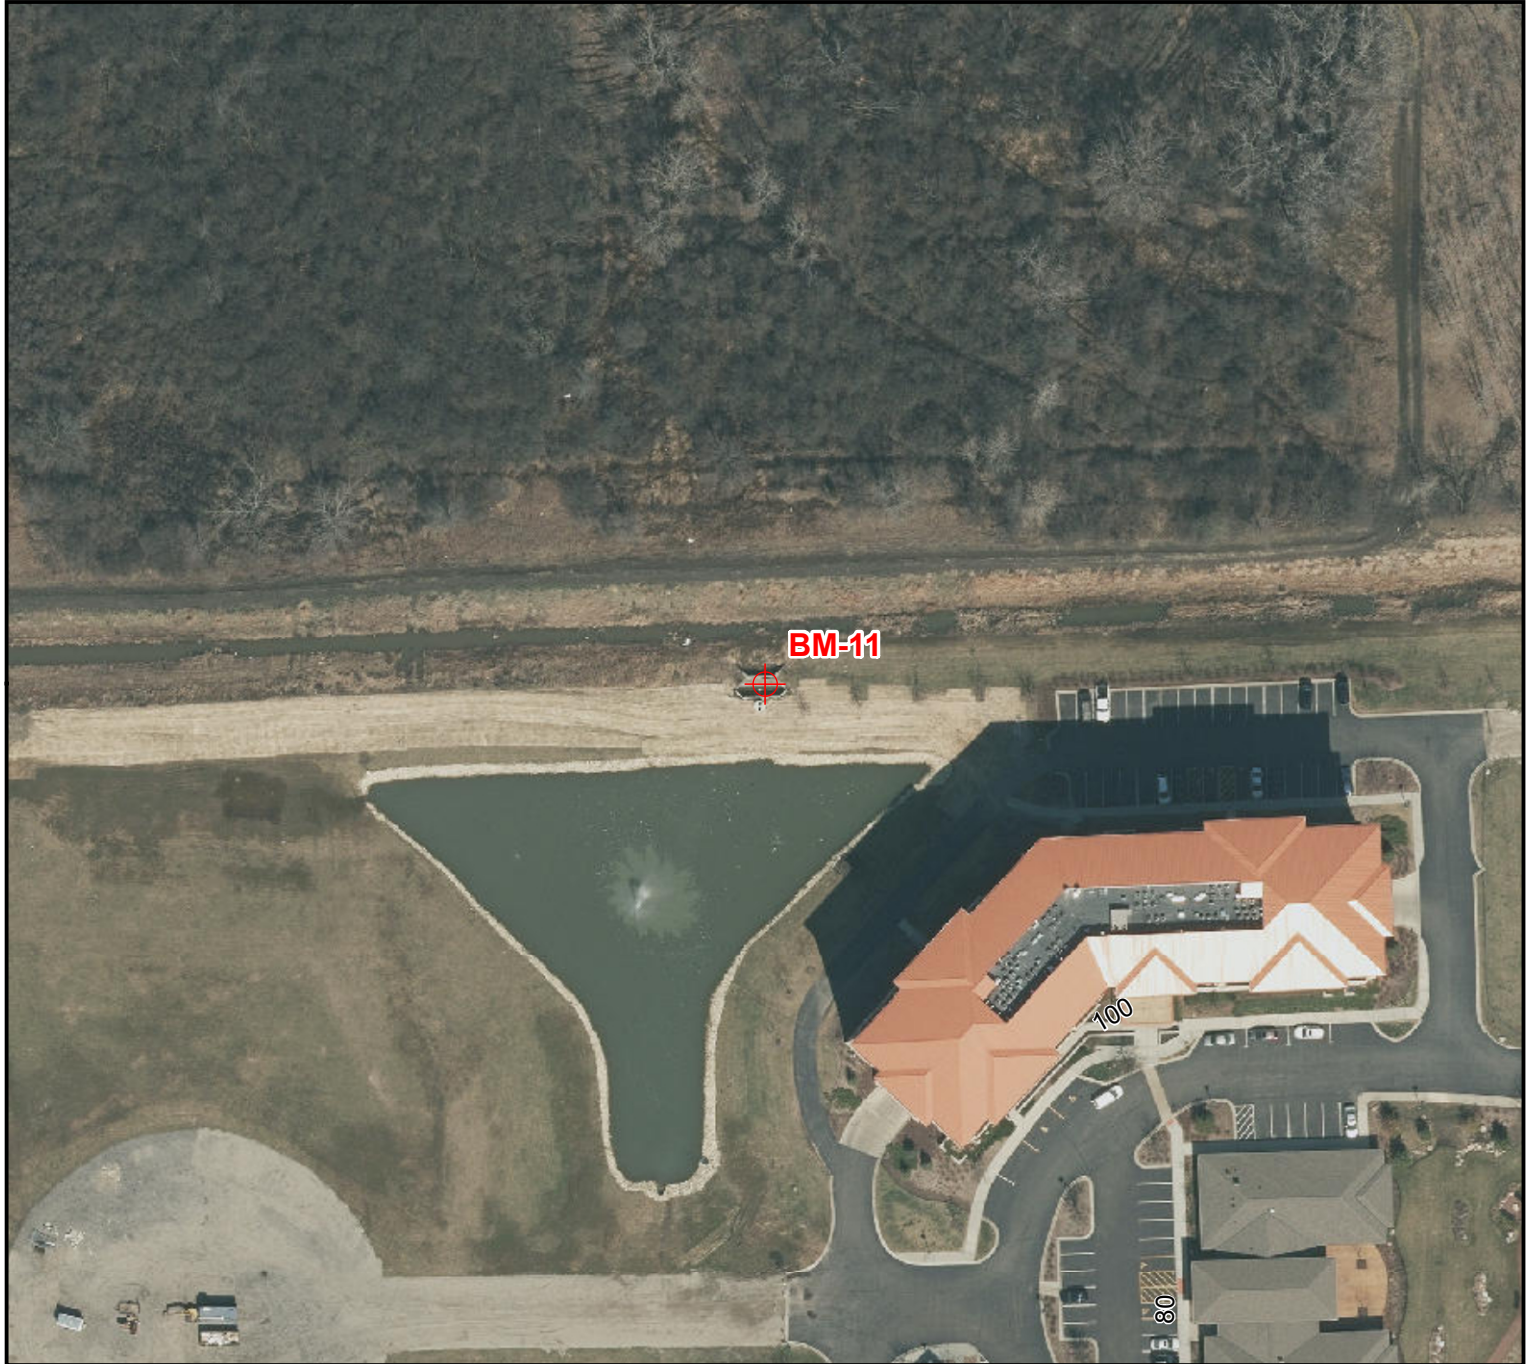
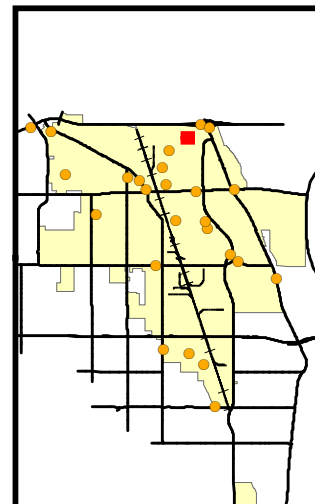
**Benchmark** BM-11  
**Northing:** 1997664.301  
**Easting:** 1096358.191  
**Elevation:** 643.952 FT  
**Description:** 2.5" Alluminum Disk Stamped  
Village of Wheeling - Survey Marker  
**Location:** Diversion Channel Outfall, NW Corner  
of 100 Prairie Park Dr.

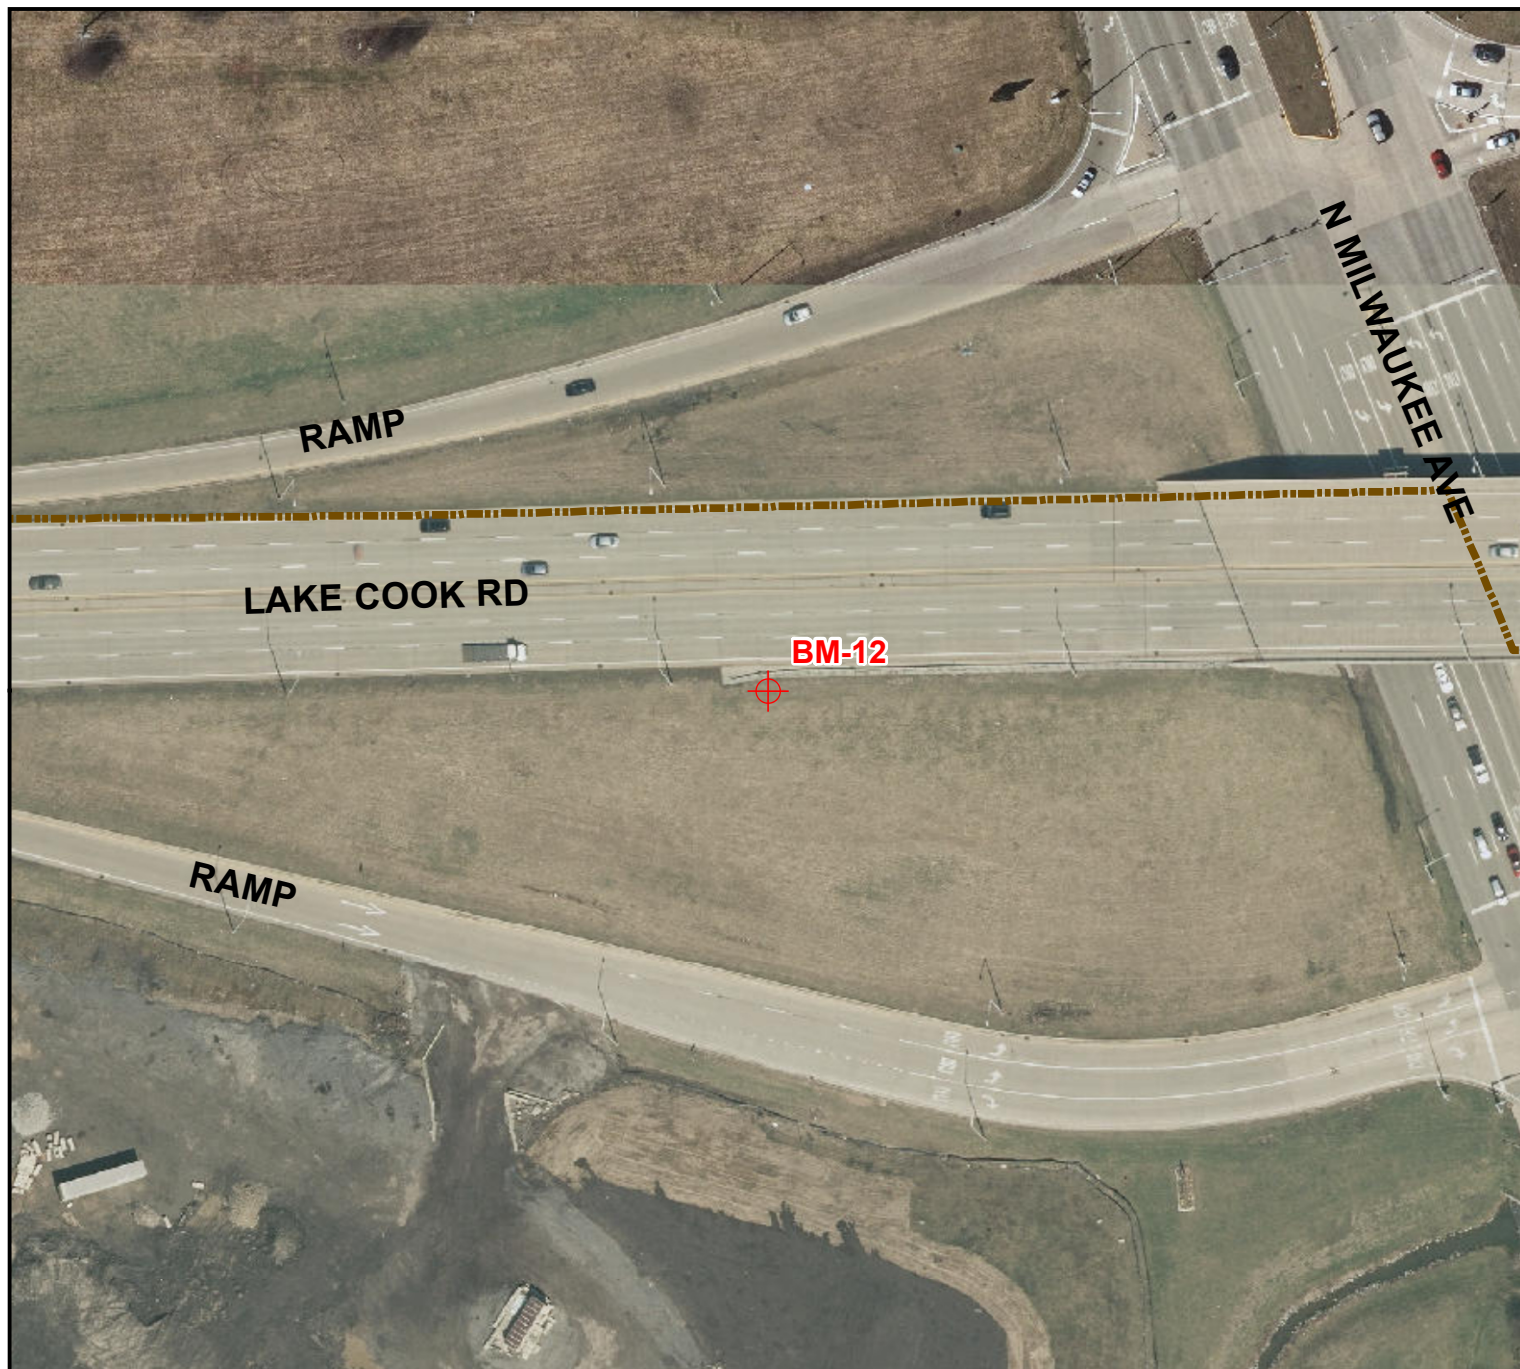
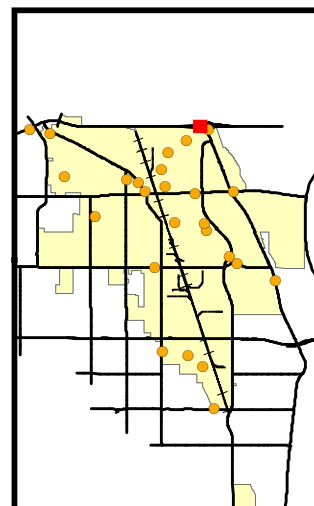
Benchmark BM-12  
Northing: 1998621.829  
Easting: 1097353.32  
Elevation: 664.621 FT  
Description: 3D Rod Monument Under Access Cover

Location: S. Side Lake Cook Rd., 250' W. of Milwaukee Ave.

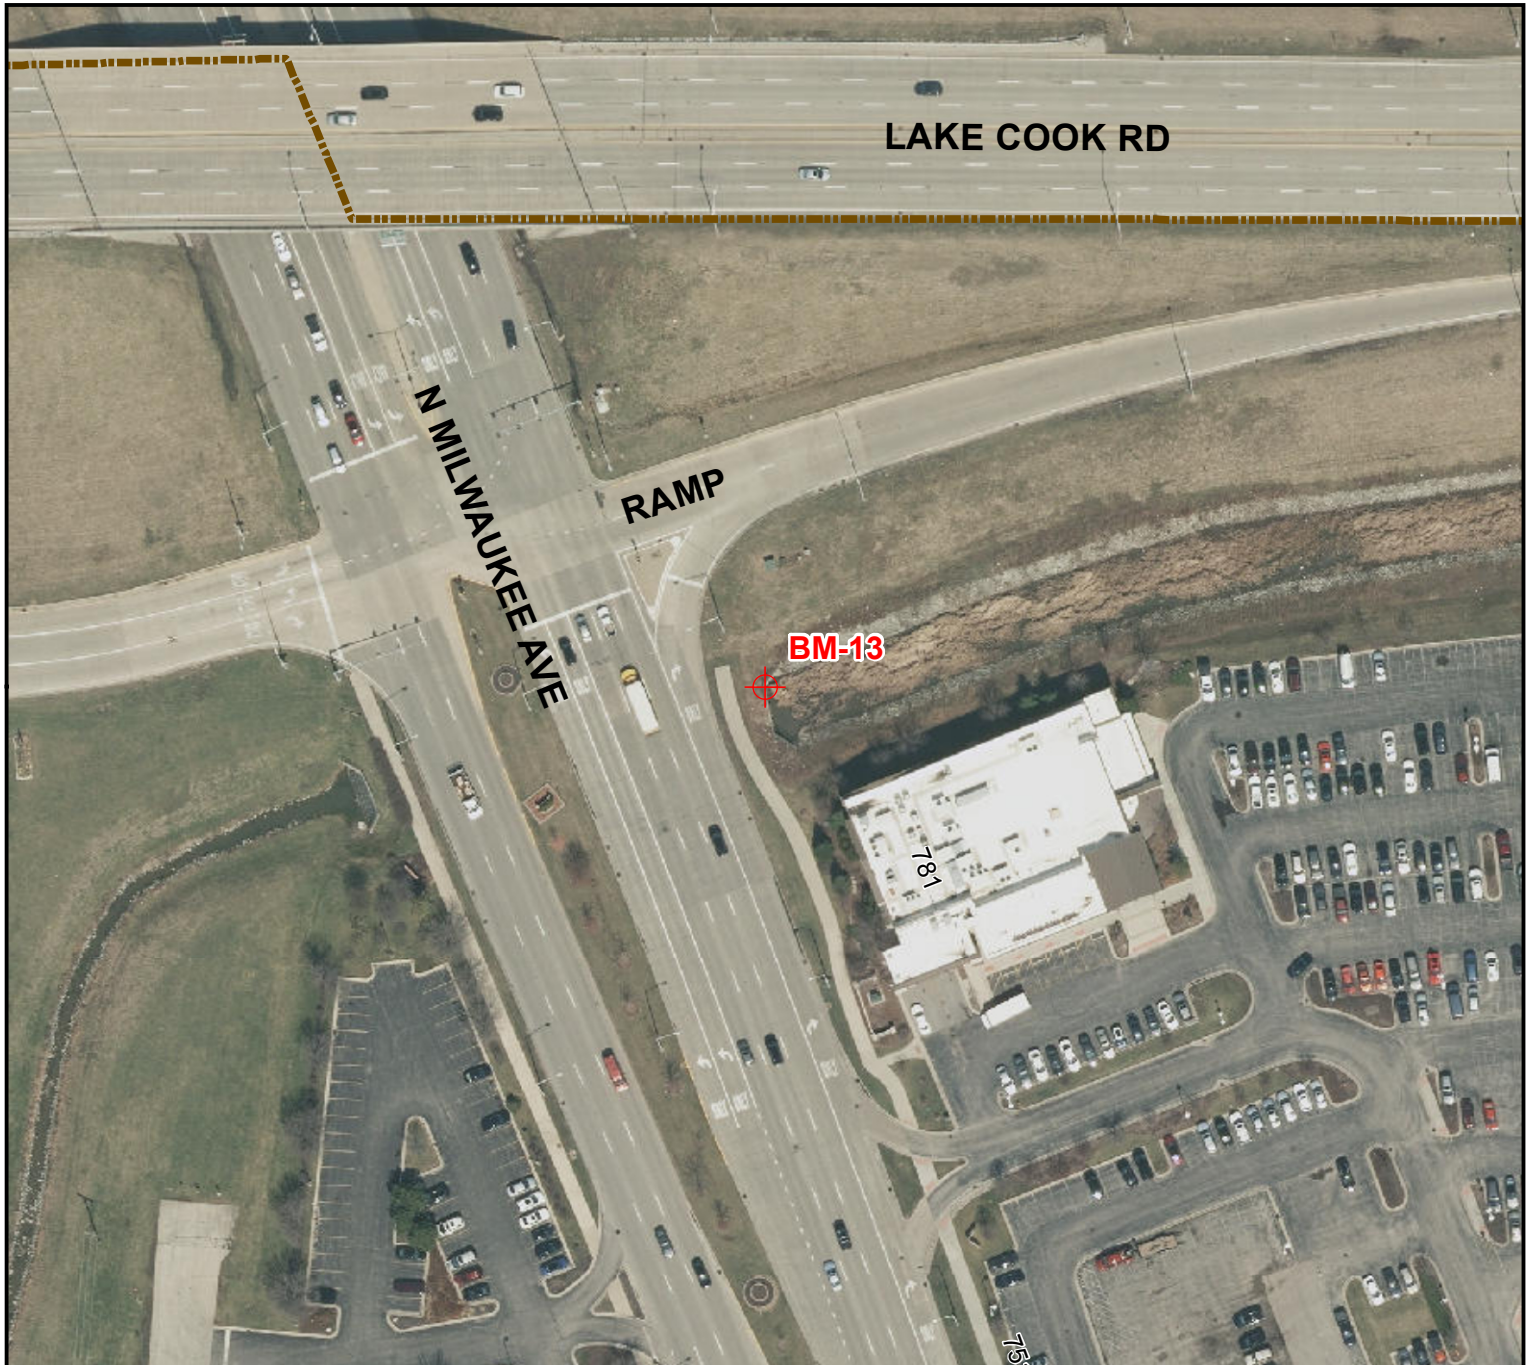
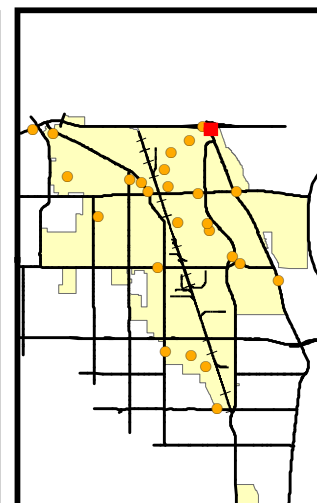
**Benchmark** BM-13  
**Northing:** 1998399.152  
**Easting:** 1097956.515  
**Elevation:** 643.181 FT  
**Description:** 2.5" Alluminum Disk Stamped  
Village of Wheeling - Survey Marker  
**Location:** NE Corner Diversion Channel Triple  
Box Culvert, Under Milwaukee Ave.

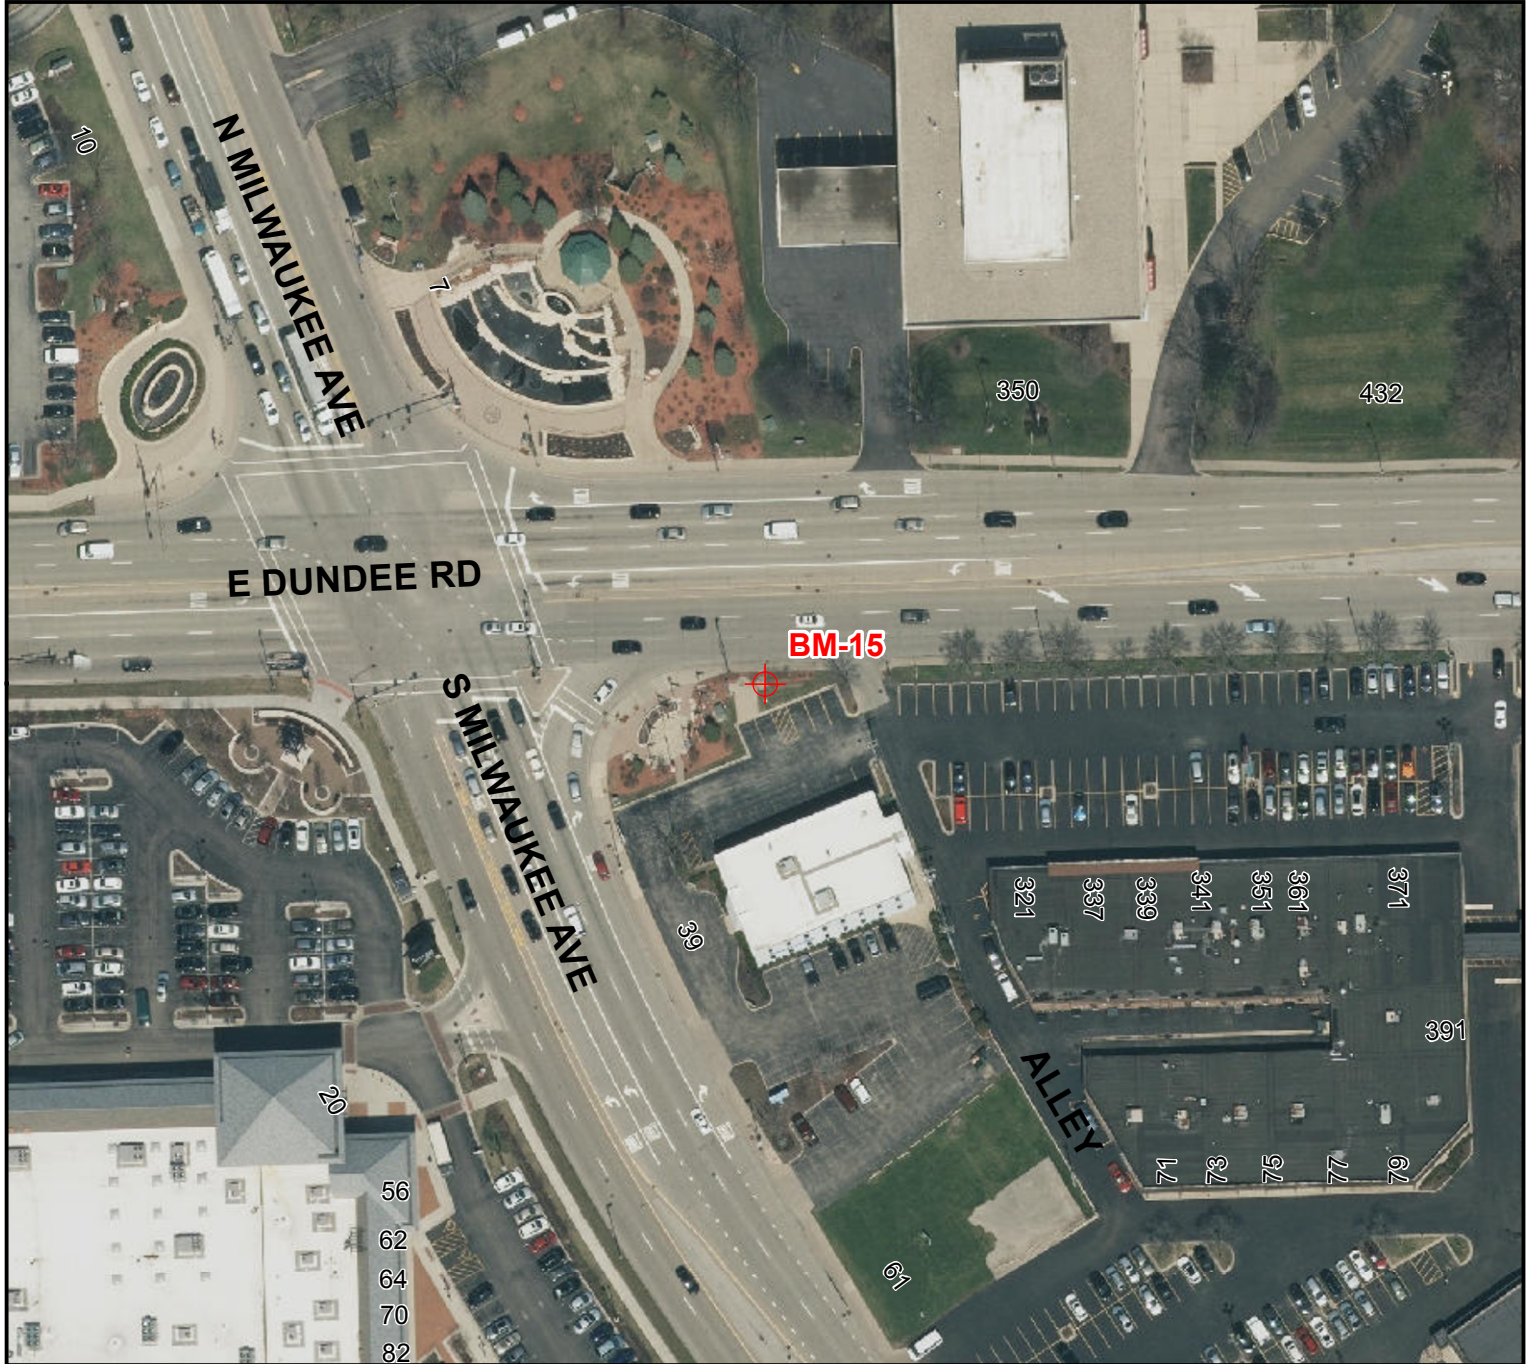
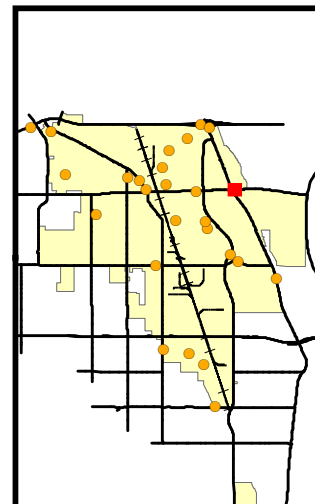
**Benchmark** BM-15  
**Northing:** 1993751.813  
**Easting:** 1099848.51  
**Elevation:** 646.315 FT  
**Description:** 2.5" Alluminum Disk Stamped  
Village of Wheeling - Survey Marker  
**Location:** SE Corner, San. Sewer Lift Station,  
Dundee Rd. & Milwaukee Ave.

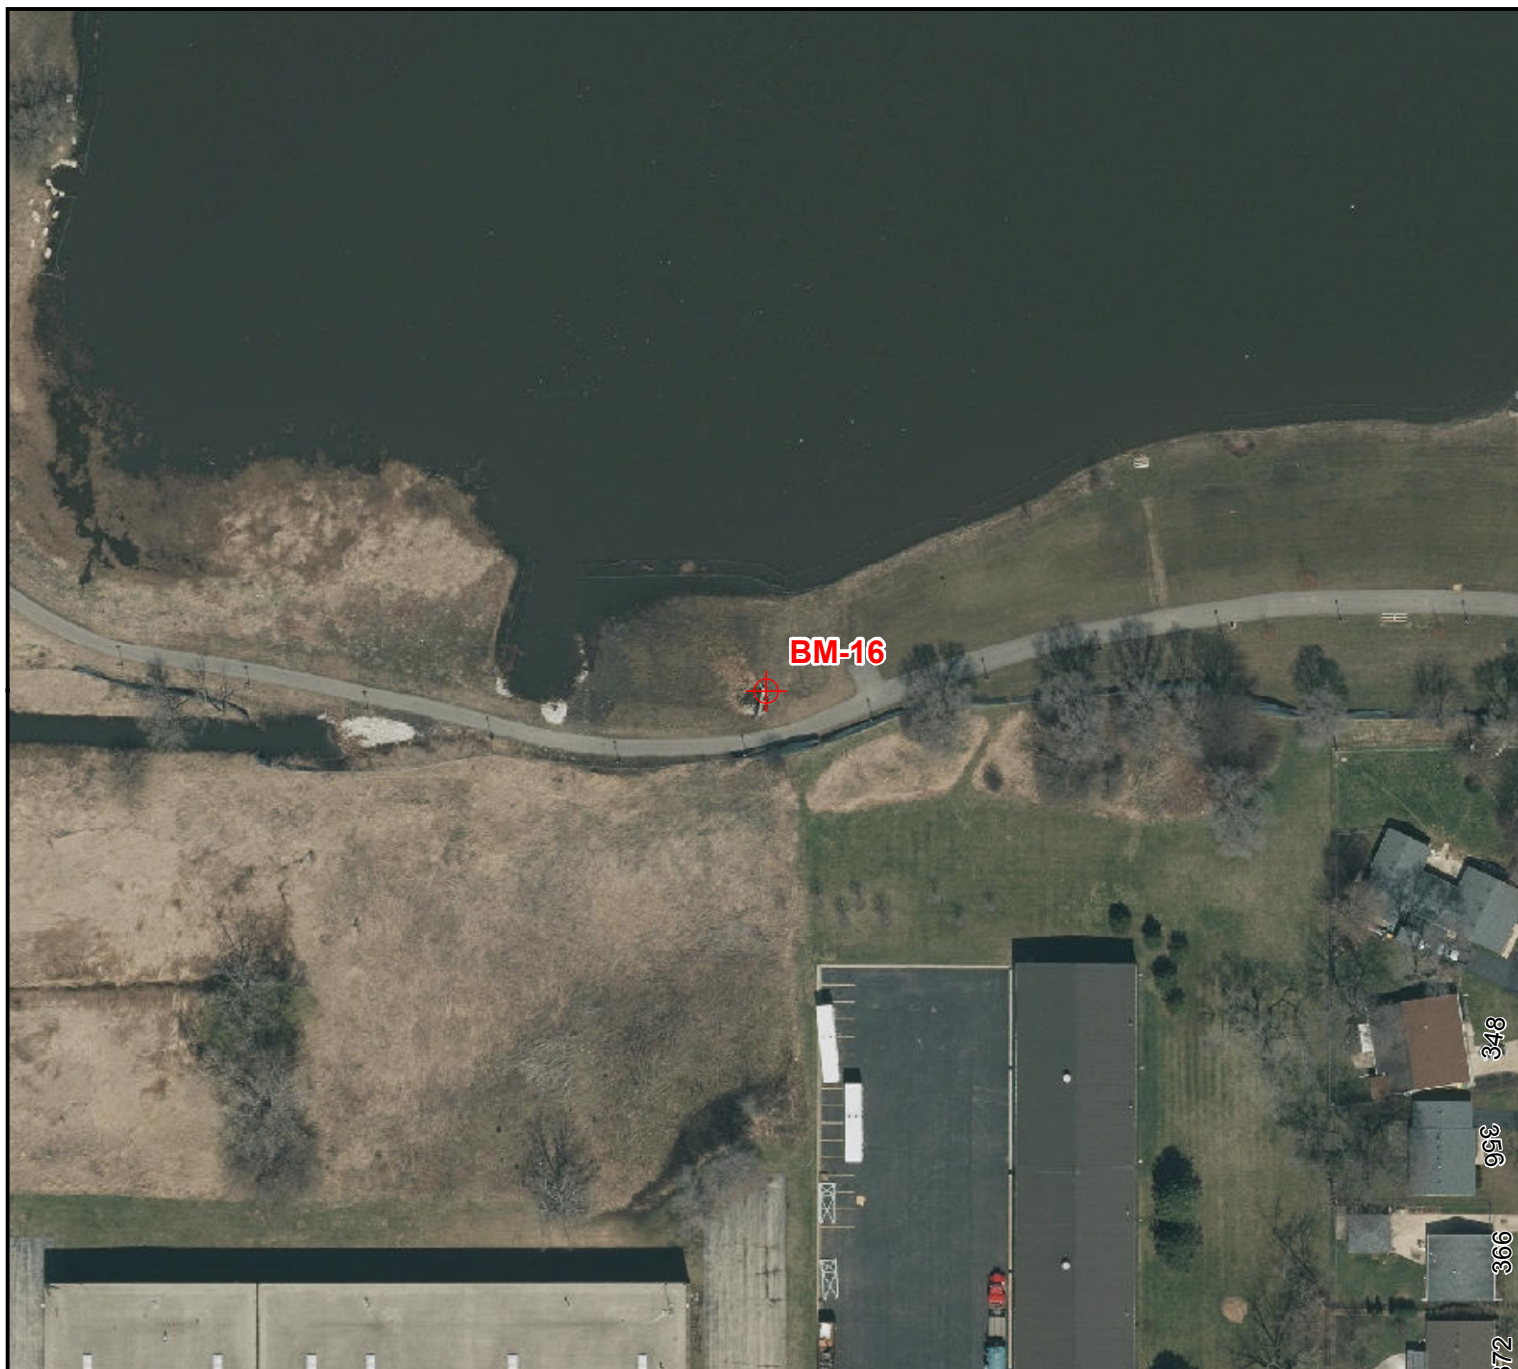
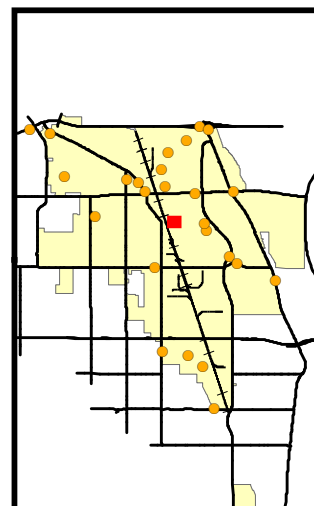
| <b>Benchmark</b> | <b>BM-16</b> |

| <b>Description:</b> | 2.5" Alluminum Disk Stamped<br>Village of Wheeling - Survey Marker |
| <b>Location:</b> | 60" Storm Sewer Control Structure, S<br>of Heritage Lake. |

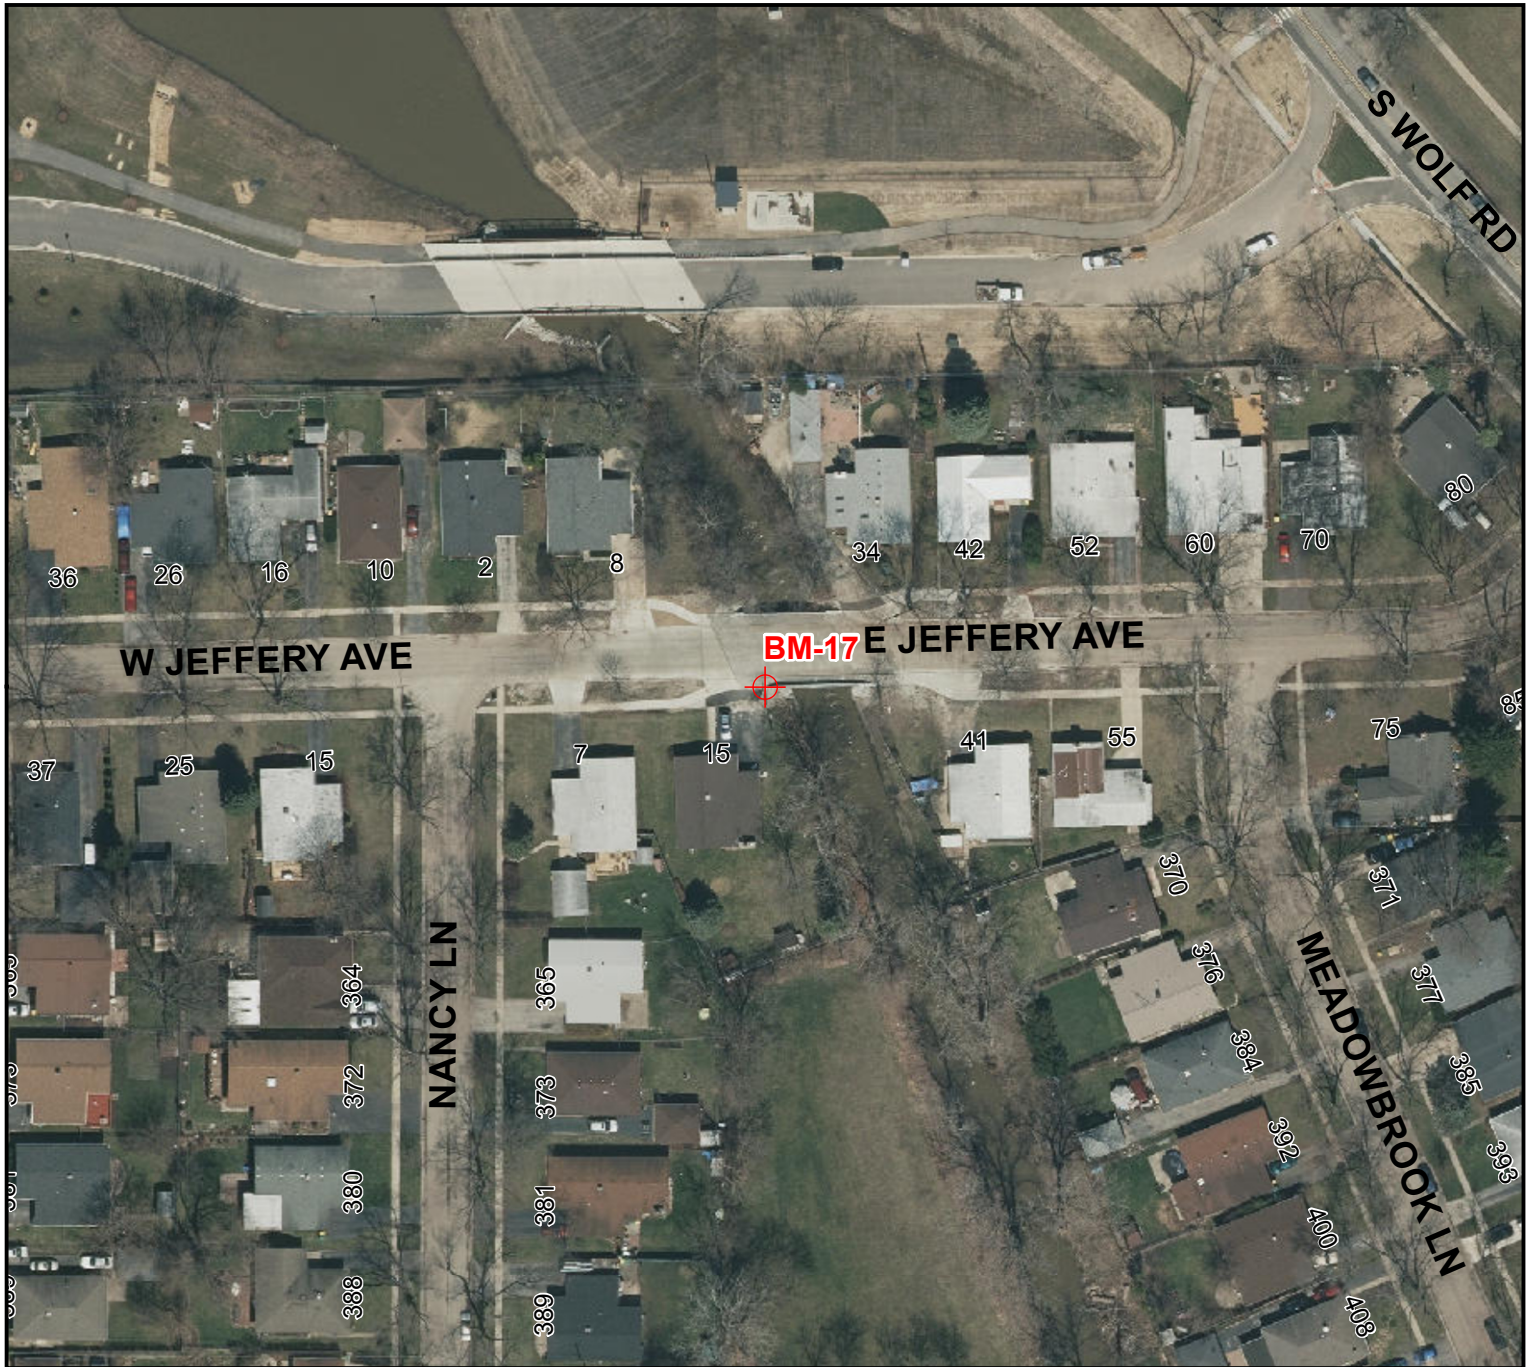
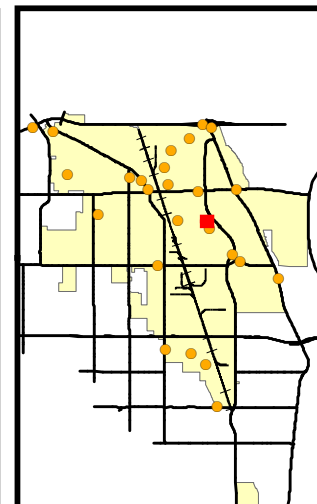
**Benchmark** BM-17  
**Northing:** 1991385.5091  
**Easting:** 1097679.41  
**Elevation:** 641.41 FT  
**Description:** 2.5" Alluminum Disk Stamped  
Village of Wheeling - Survey Marker  
**Location:** SW Corner of Jeffrey Ave. Bridge,  
~215' W. of Meadowbrook Ln.

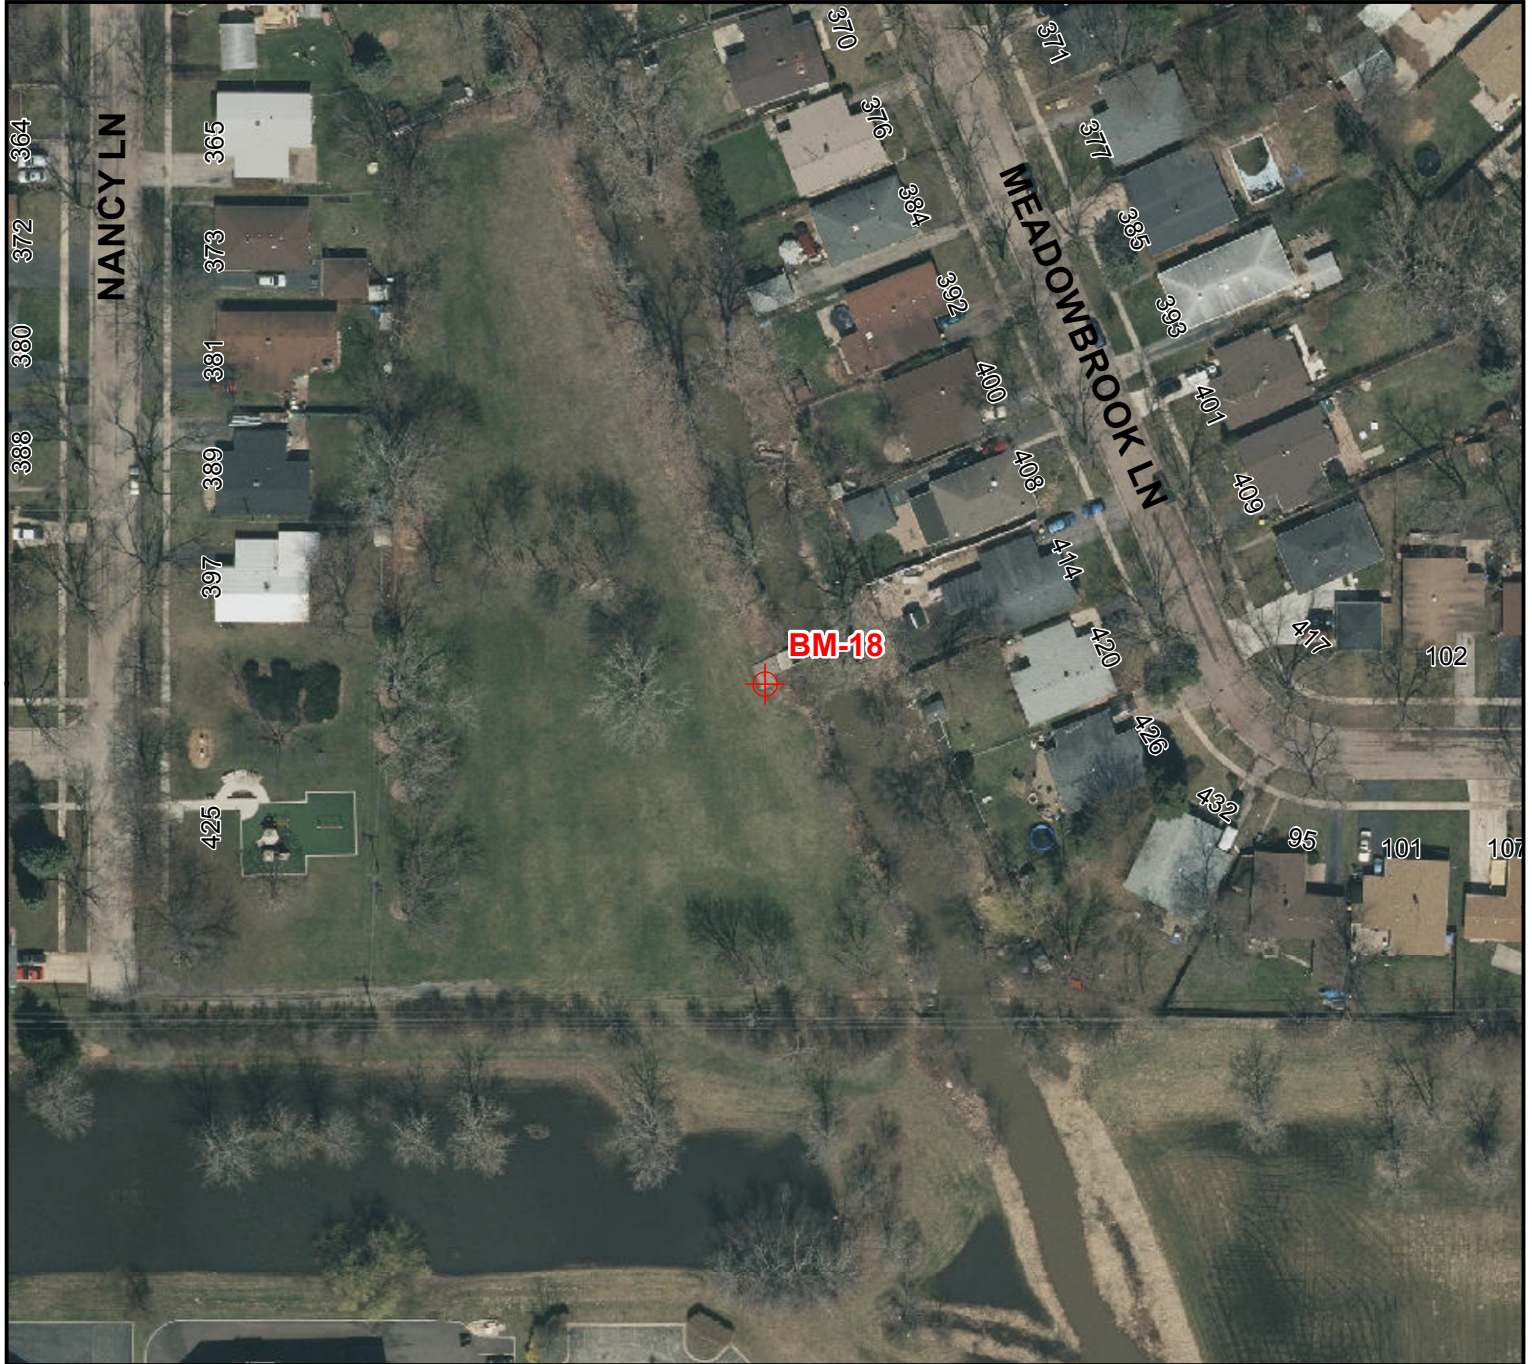
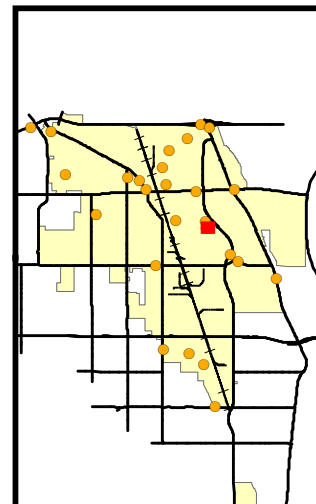
**Benchmark** BM-18  
**Northing:** 1990946.696  
**Easting:** 1097851.985  
**Elevation:** 641.871 FT  
**Description:** 2.5" Alluminum Disk Stamped  
Village of Wheeling - Survey Marker  
**Location:** Concrete Structure, W. Side of 425  
Nancy Ln.

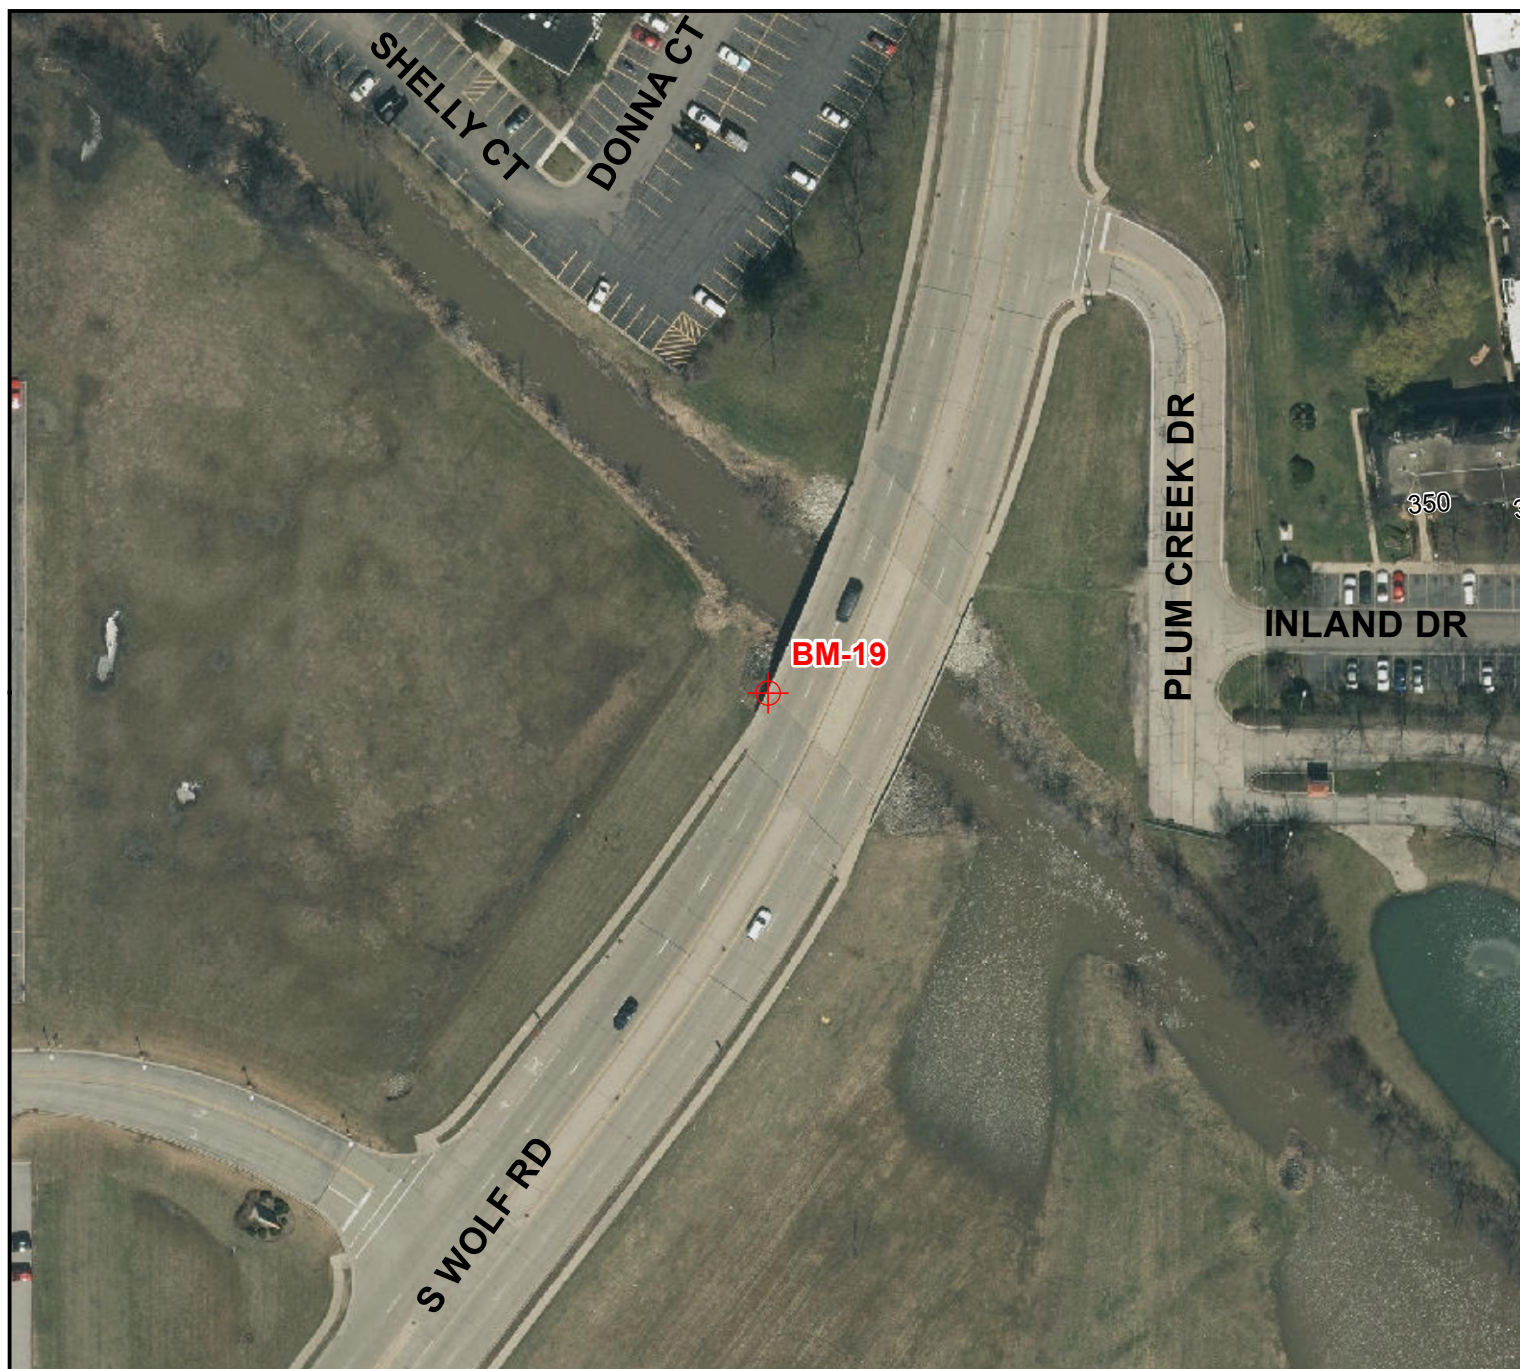
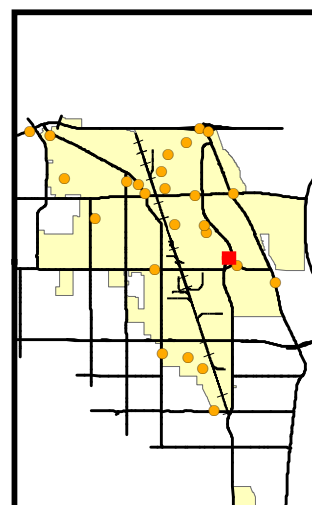
**Benchmark** BM-19  
**Northing:** 1988991.068  
**Easting:** 1099537.722  
**Elevation:** 650.951 FT  
**Description:** 2.5" Alluminum Disk Stamped  
Village of Wheeling - Survey Marker  
**Location:** SW Corner of Wolf Rd. Bridge, ~900'  
N. of Hintz Rd.

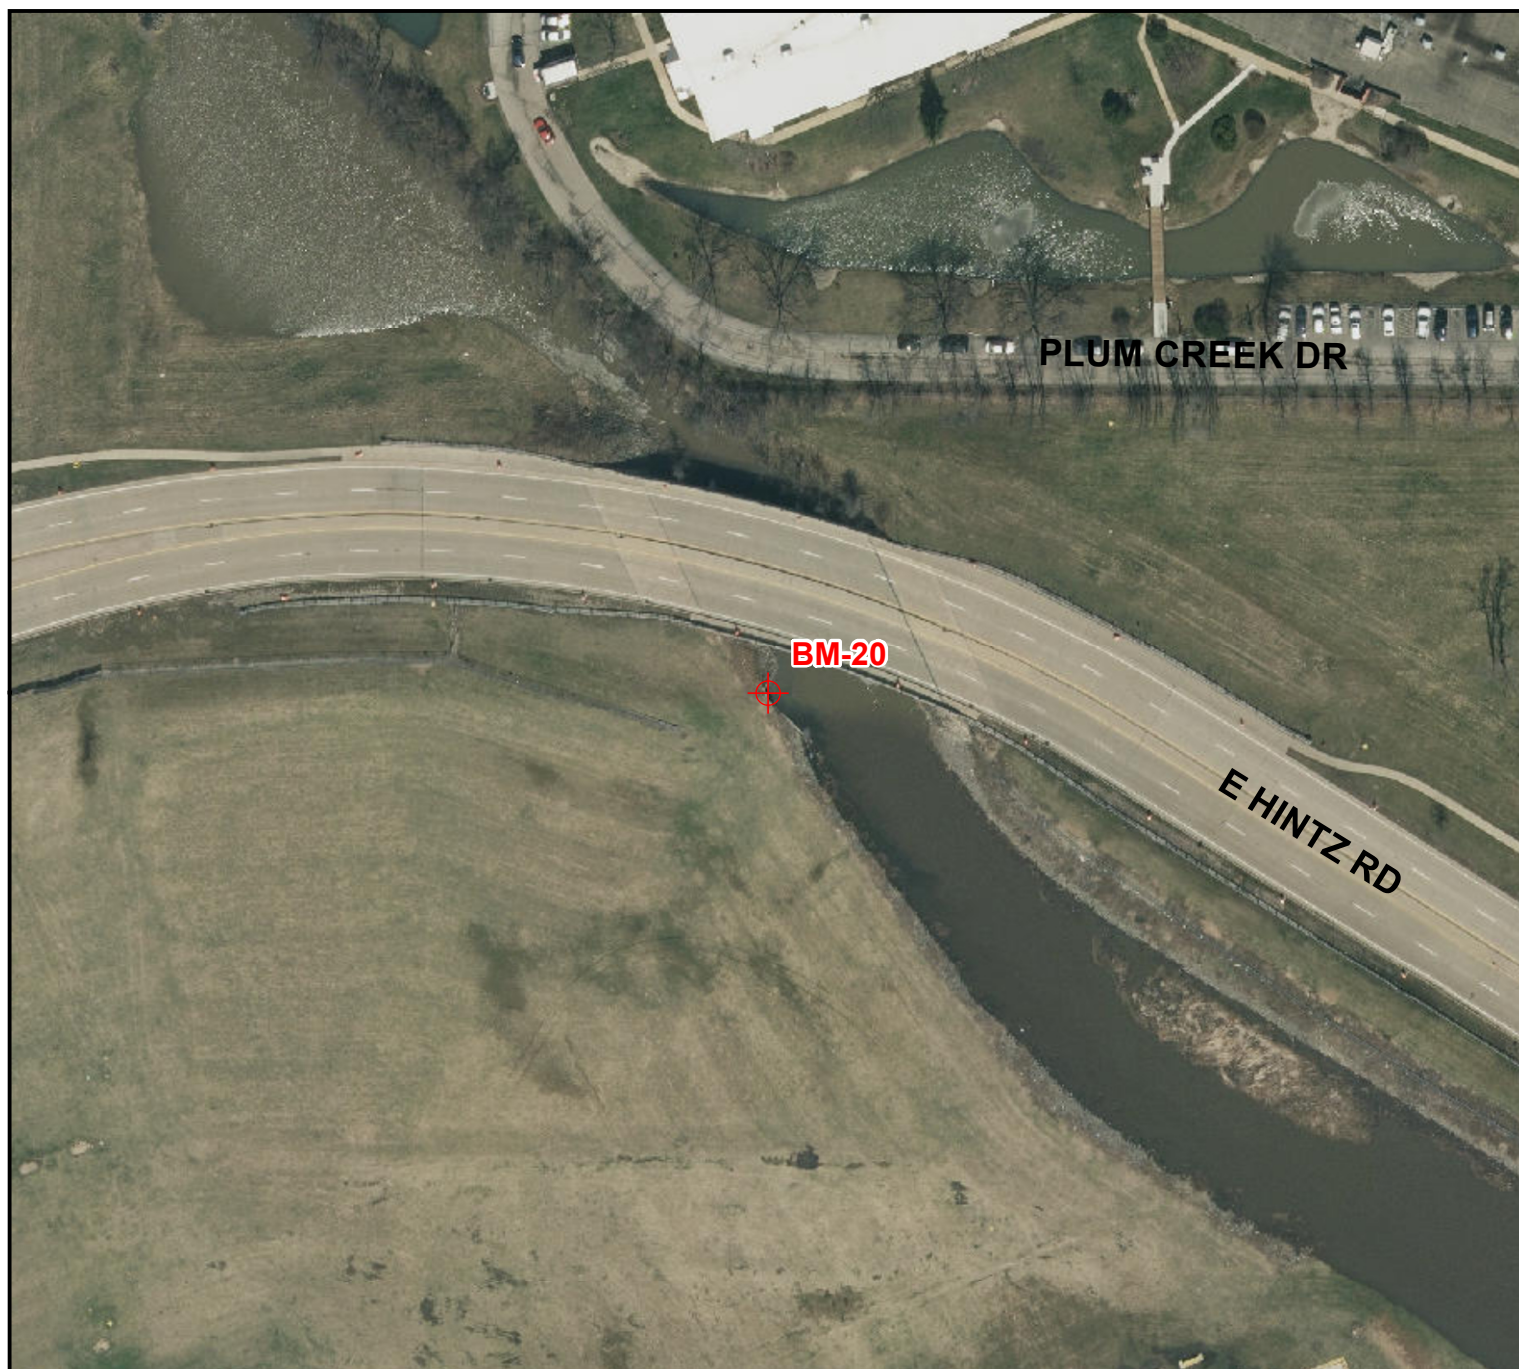
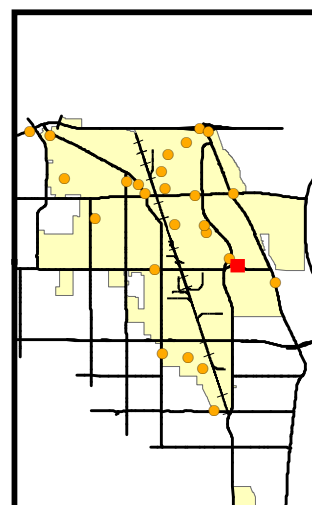
**Benchmark** BM-20  
**Northing:** 1988387.328  
**Easting:** 1100131.524  
**Elevation:** 638.395 FT  
**Description:** 2.5" Alluminum Disk Stamped  
Village of Wheeling - Survey Marker  
**Location:** S. of Hintz Rd. Bridge, W. of Buffalo  
Creek, ~1000' E. of Wolf Rd.
