# Village of Wheeling

## Benchmark Locations

BenchmarkMap\_8.5x11\_20170131  
JVD, Jan. 31st 2017

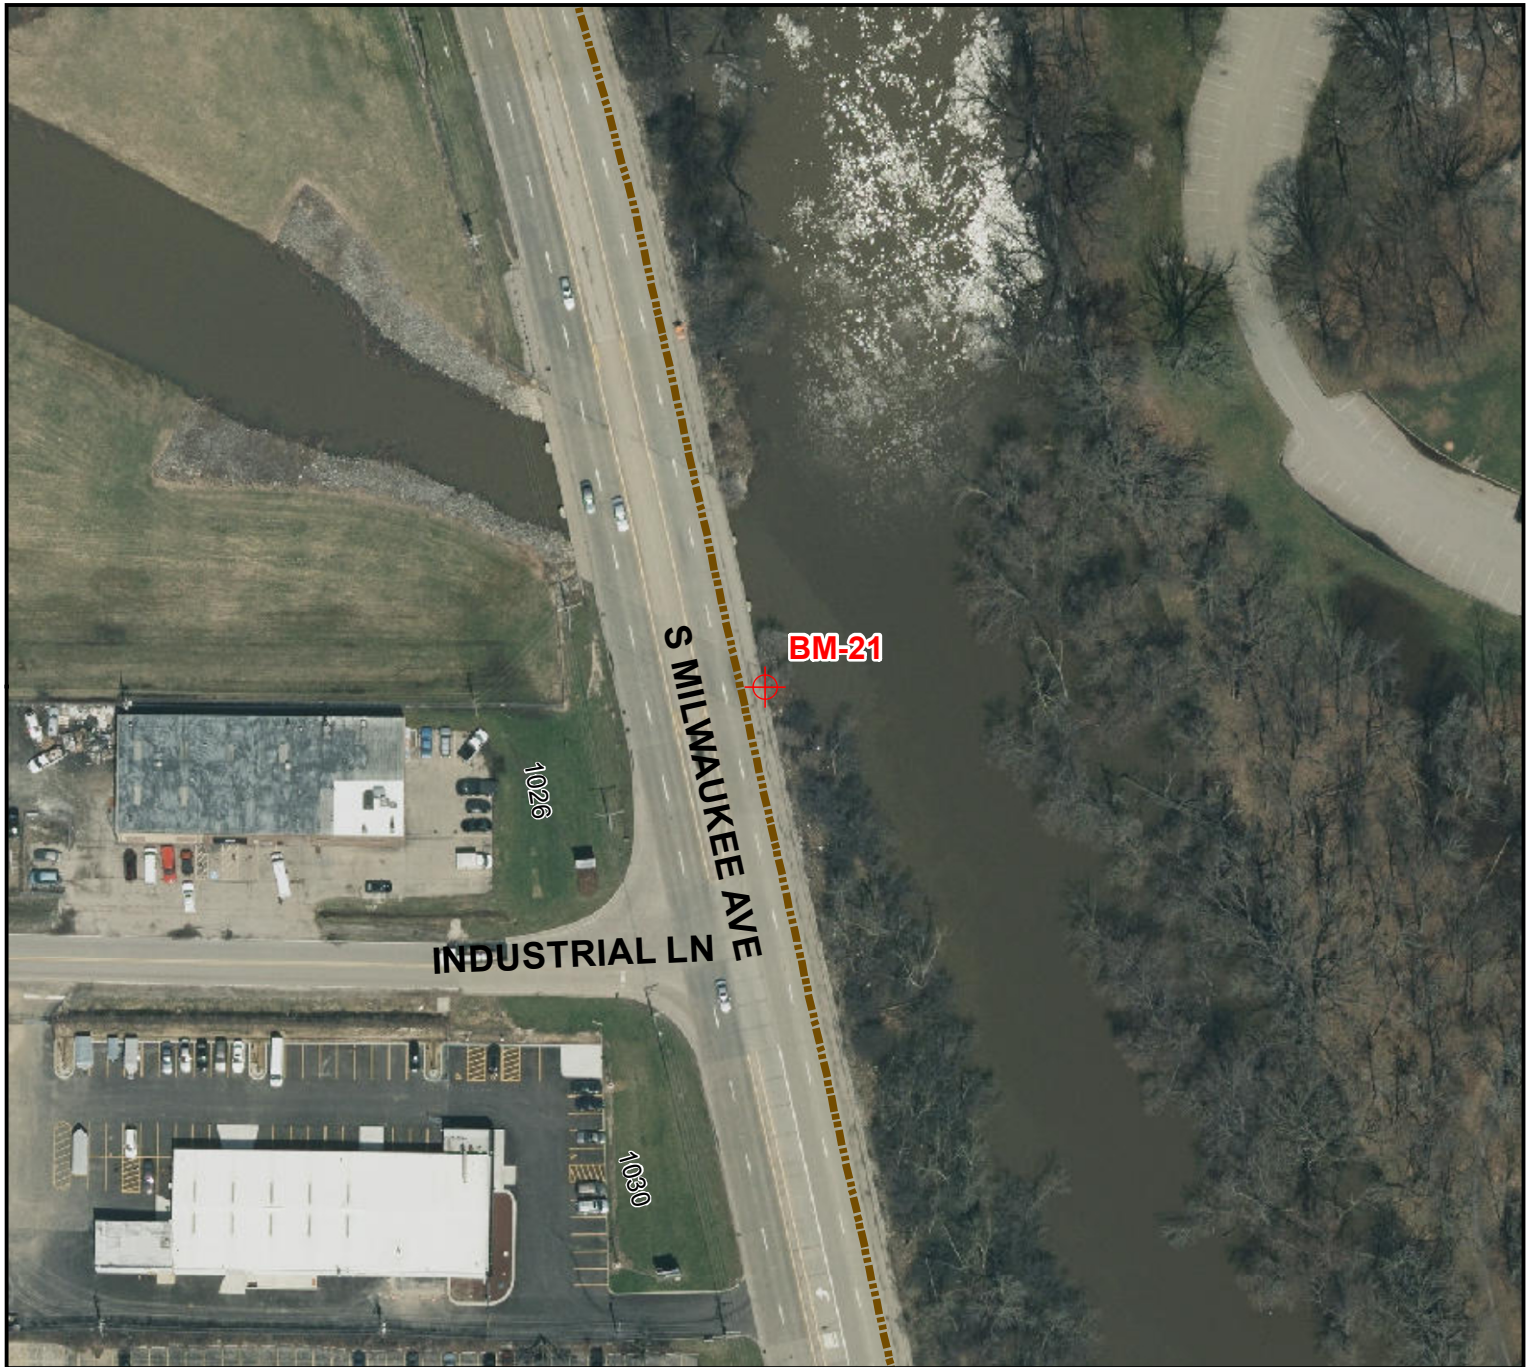
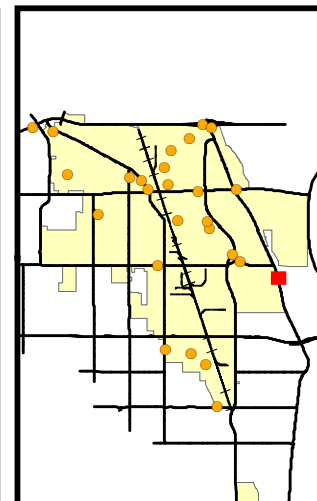
**Benchmark** BM-21  
**Northing:** 1987178.624  
**Easting:** 1102983.913  
**Elevation:** 644.908 FT  
**Description:** 2.5" Alluminum Disk Stamped  
Village of Wheeling - Survey Marker  
**Location:** SE Corner of Milwaukee Ave. Bridge,  
~115' N of Industrial Ln.

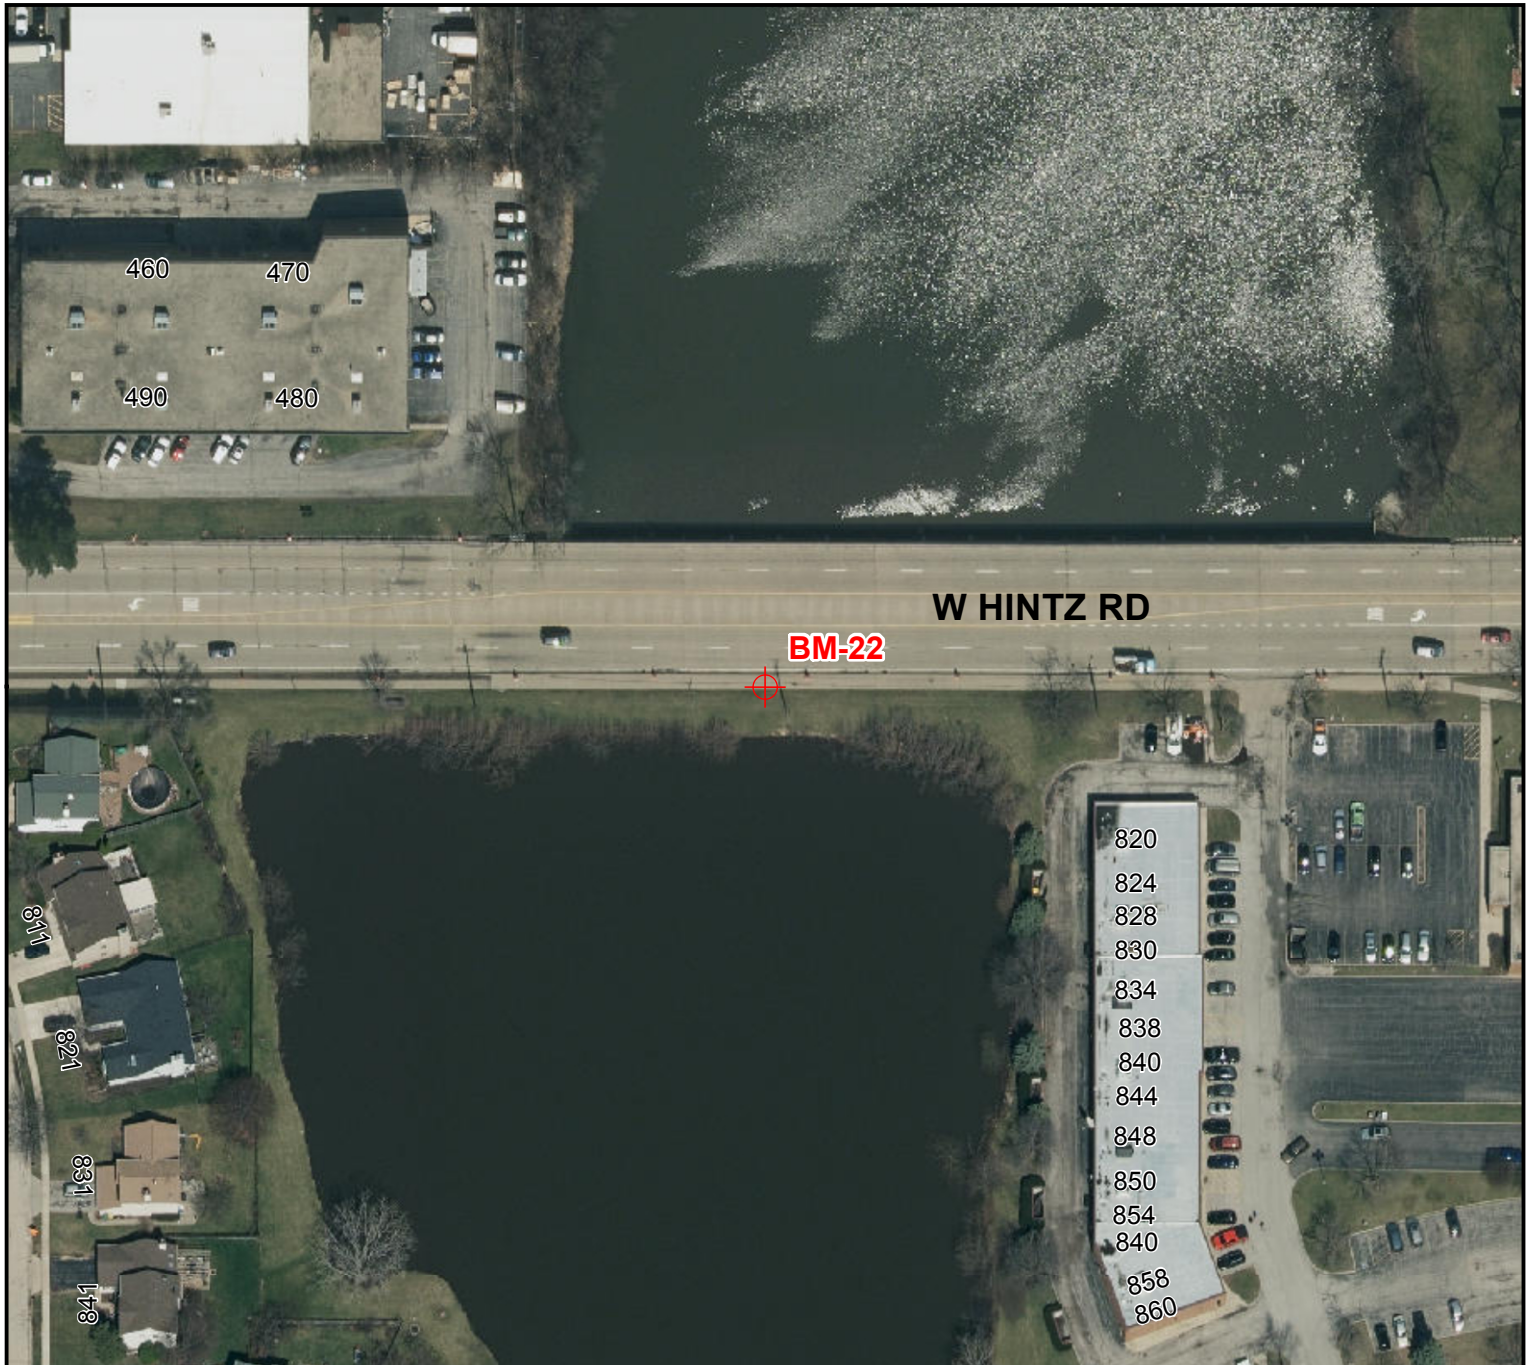
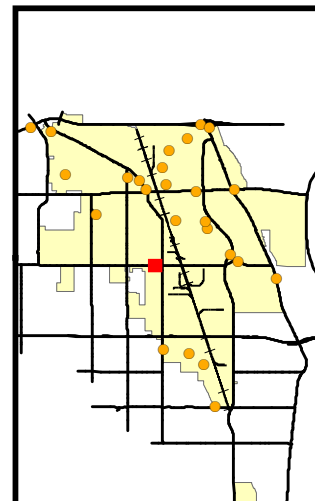
**Benchmark** BM-22  
**Northing:** 1988088.079  
**Easting:** 1093942.57  
**Elevation:** 649.119 FT  
**Description:** 2.5" Alluminum Disk Stamped  
Village of Wheeling - Survey Marker  
**Location:** S. Side of Hintz Rd. Bridge, ~500' W.  
of Wheeling Rd.

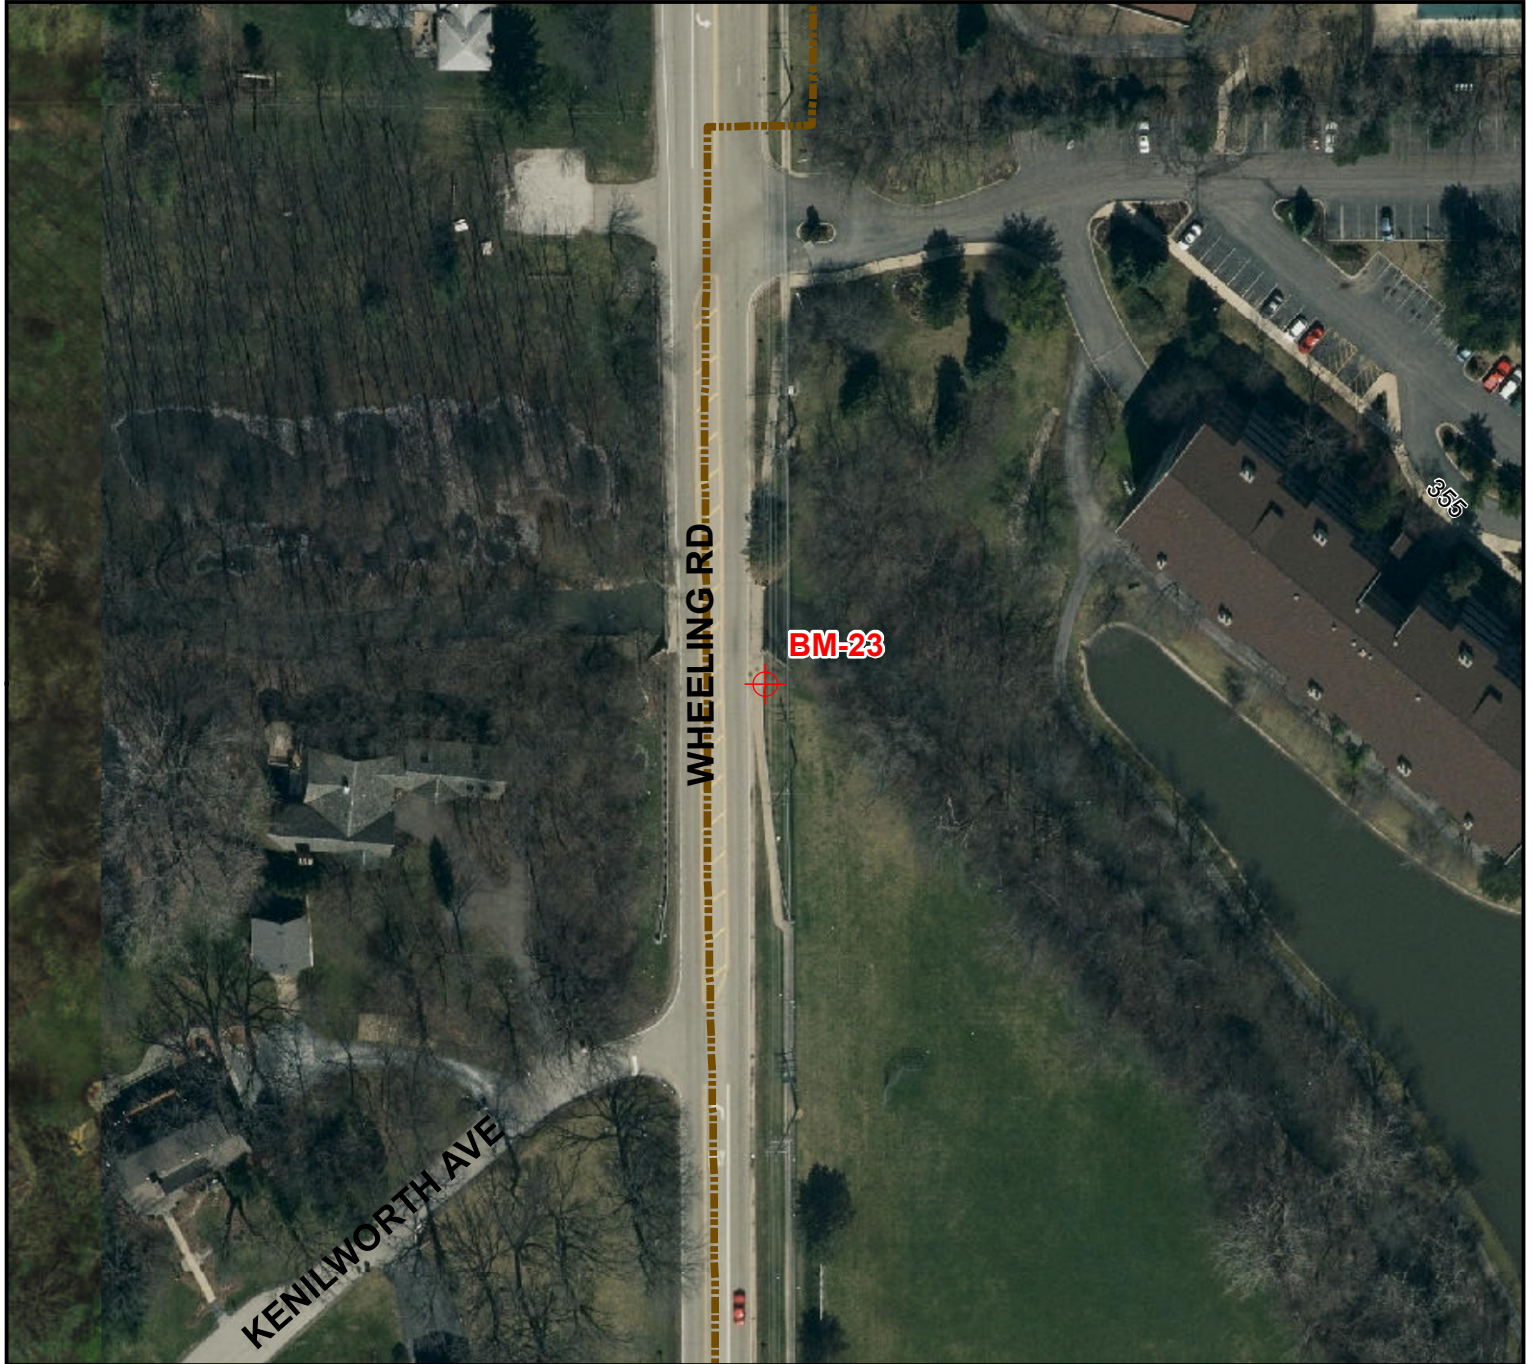
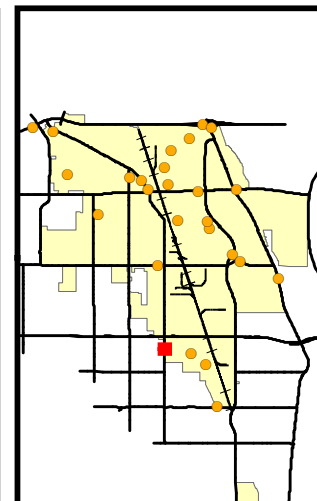
**Benchmark** BM-23  
**Northing:** 1981878.084  
**Easting:** 1094517.228  
**Elevation:** 655.116 FT  
**Description:** 2.5" Alluminum Disk Stamped Village of Wheeling - Survey Marker  
**Location:** SE Corner of Wheeling Rd. Bridge, ~900' S. of Palatine Rd.

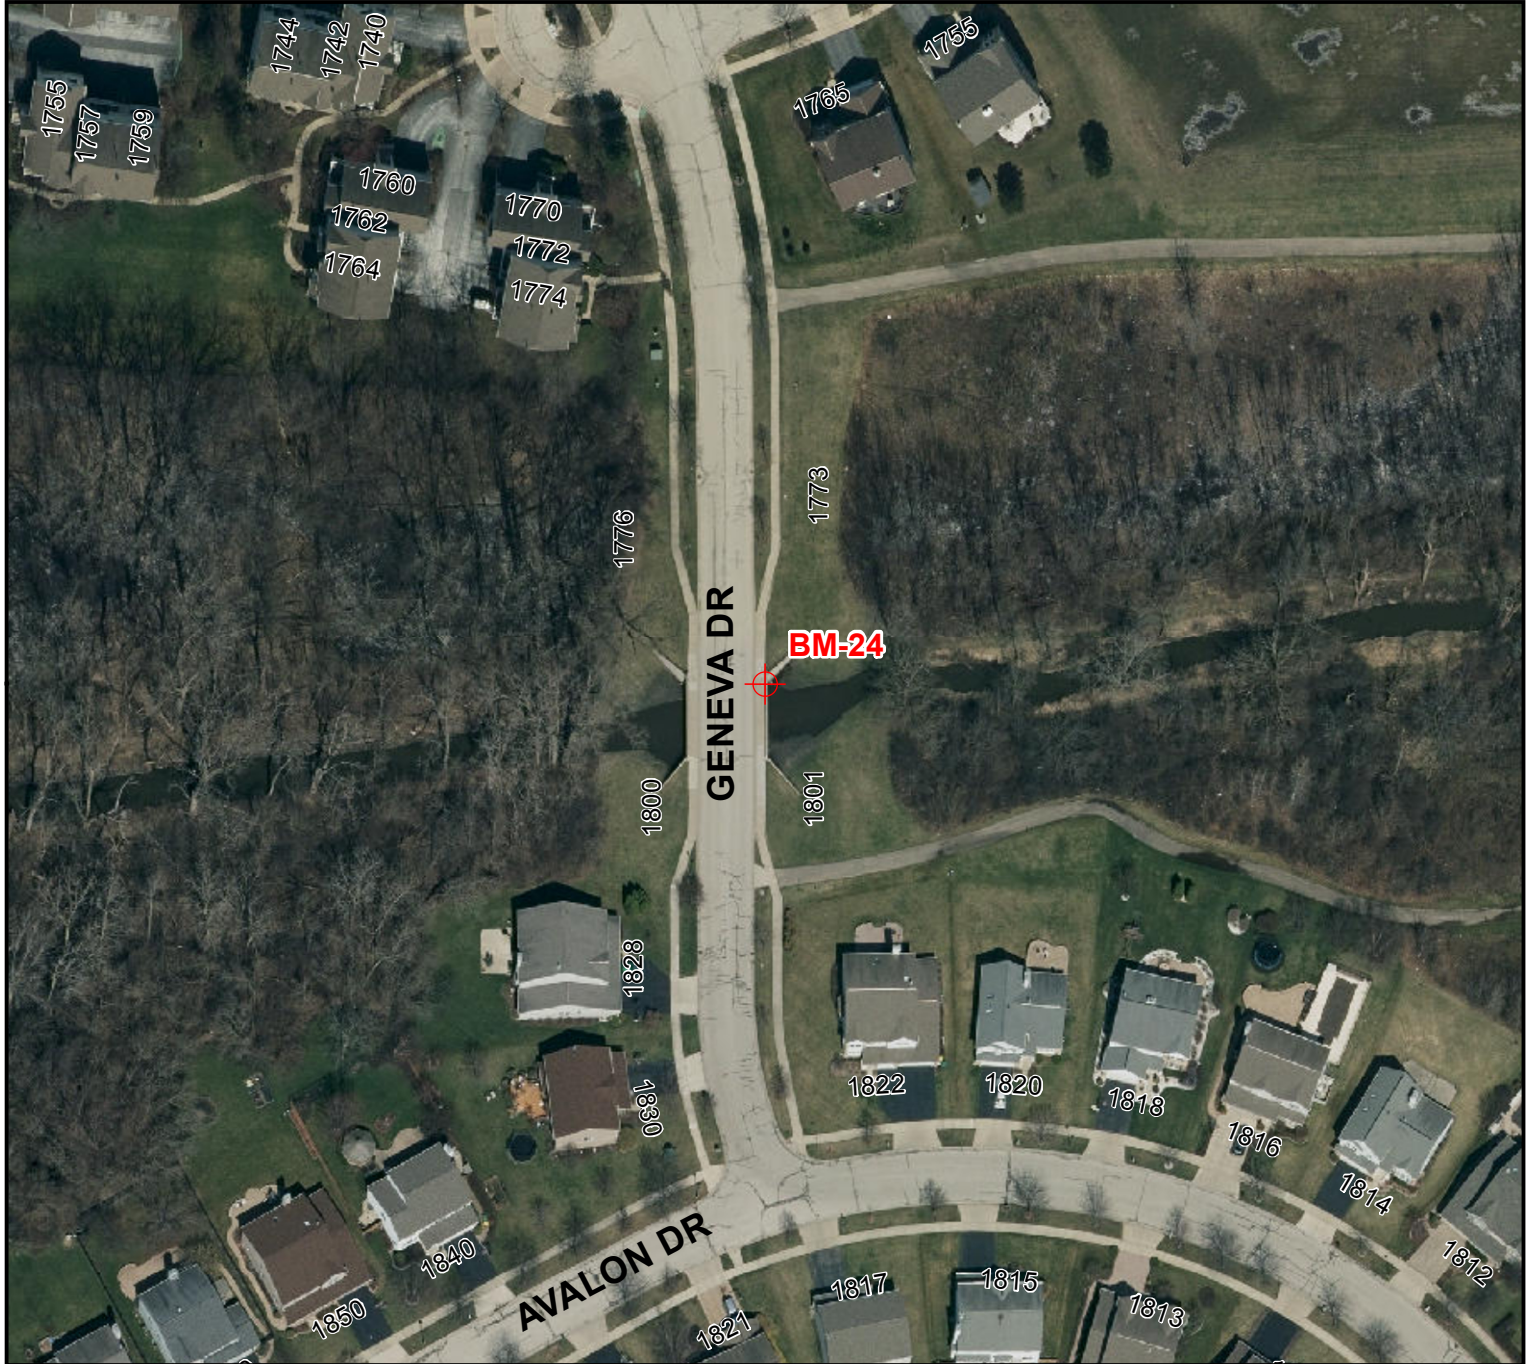
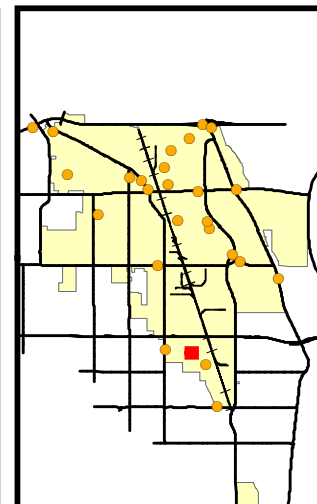
**Benchmark** BM-24  
**Northing:** 1981602.371  
**Easting:** 1096474.302  
**Elevation:** 656.901 FT  
**Description:** 2.5" Alluminum Disk Stamped  
Village of Wheeling - Survey Marker  
**Location:** NE Corner of Geneva Dr. Bridge over  
McDonald Creek, ~250' N. of Avalon  
Dr.

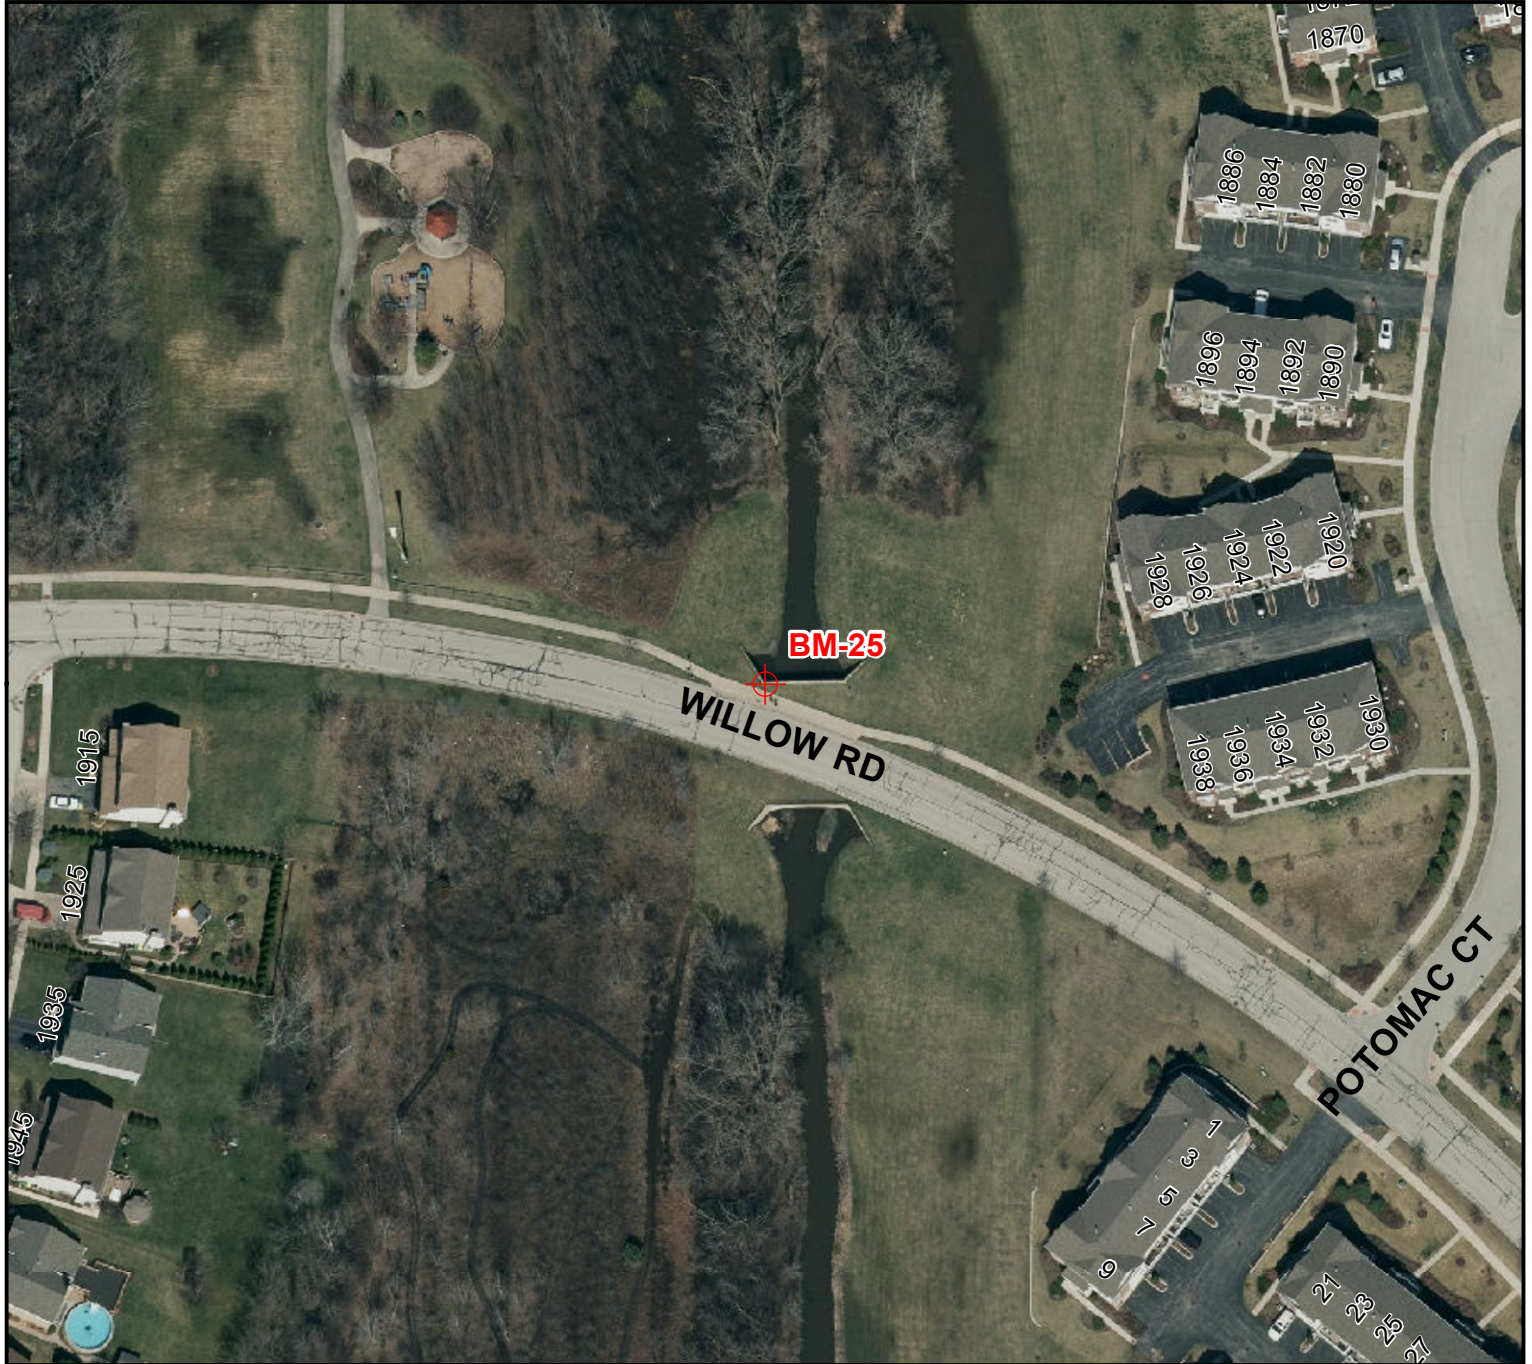
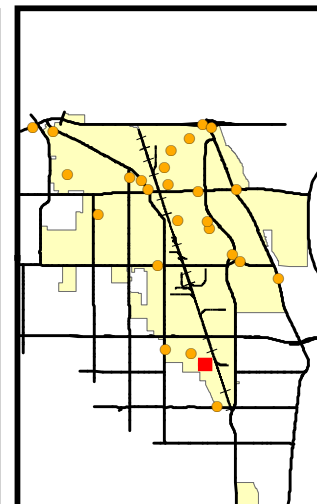
**Benchmark** BM-25  
**Northing:** 1980721.713  
**Easting:** 1097524.348  
**Elevation:** 652.302 FT  
**Description:** 2.5" Alluminum Disk Stamped  
Village of Wheeling - Survey Marker  
**Location:** NW Corner of Willow Rd. Bridge over  
McDonald Creek, ~350' W. of  
Potomac Ct.

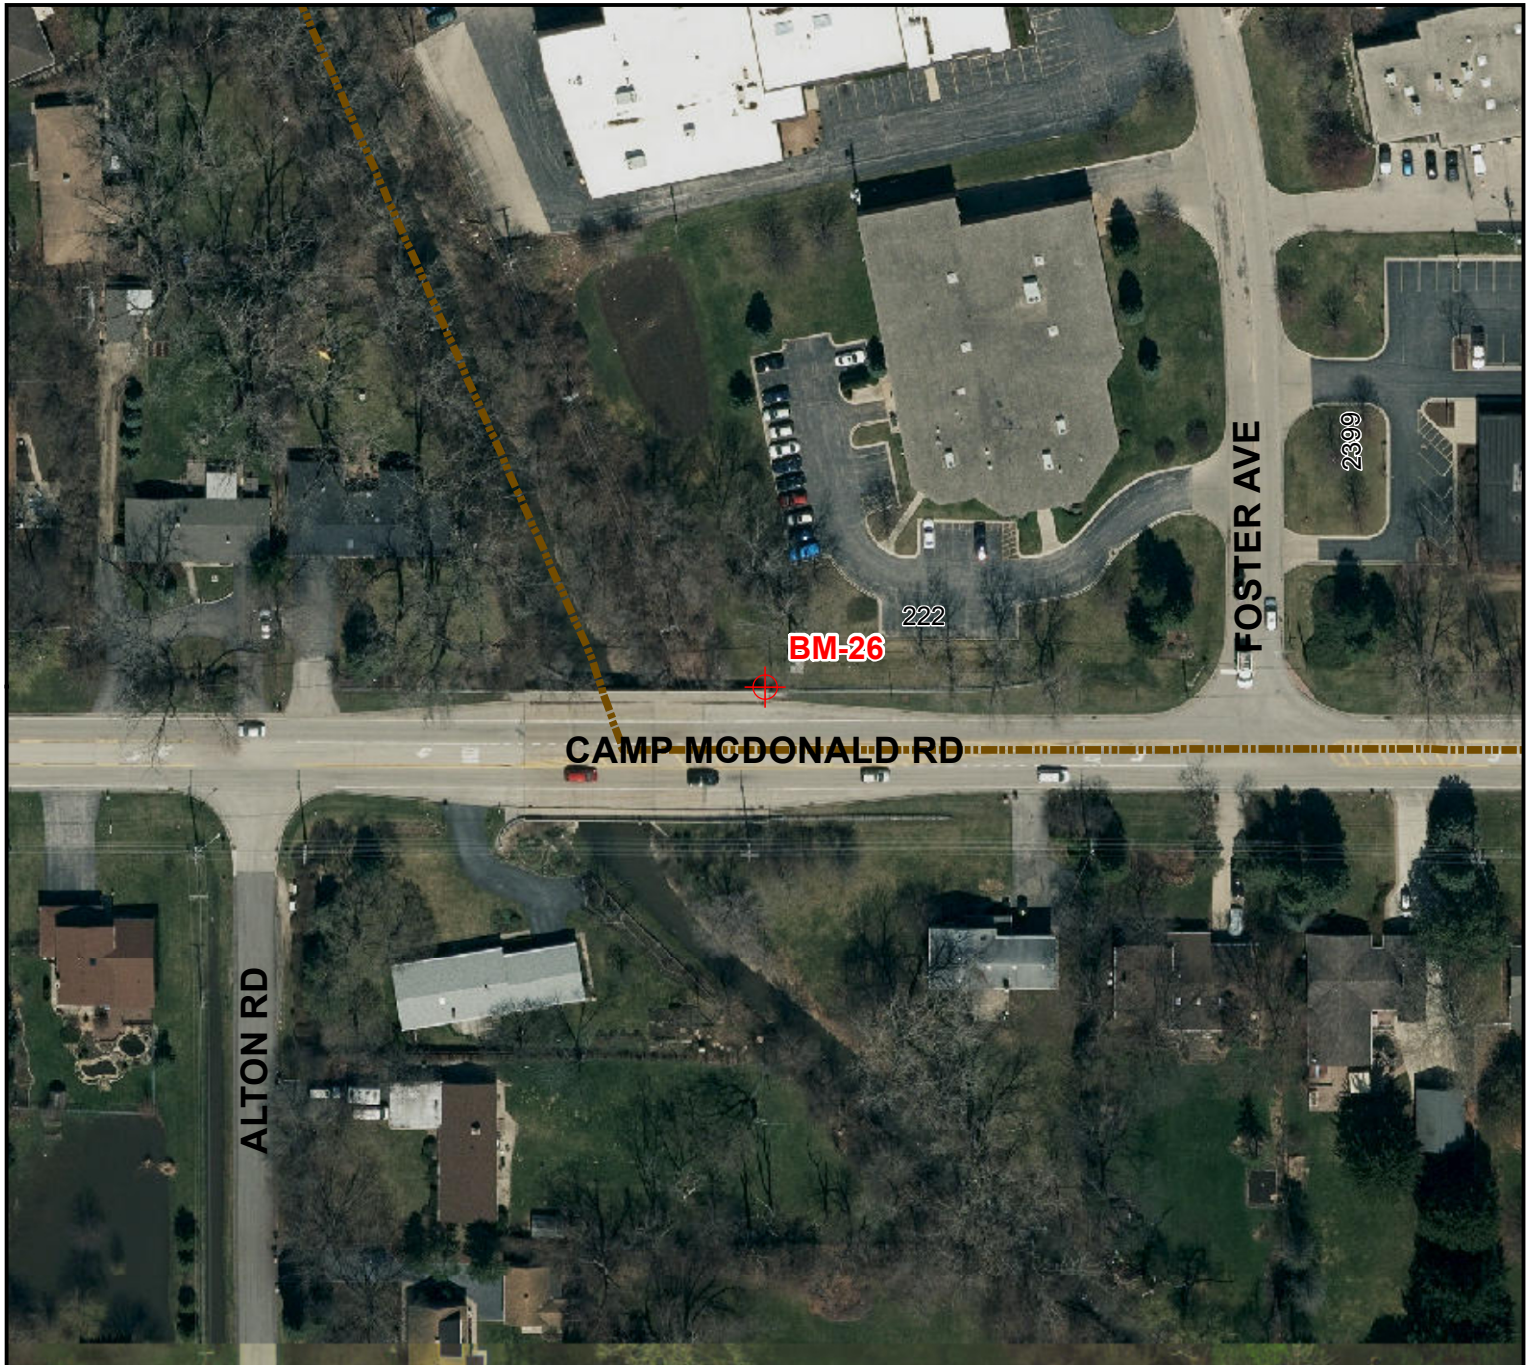
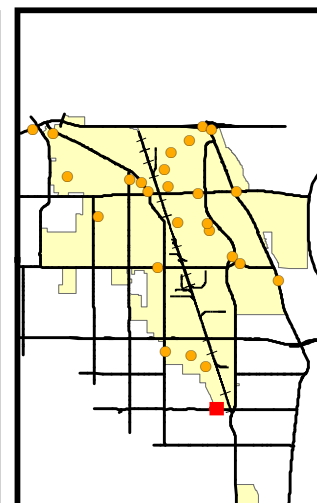
**Benchmark** BM-26  
**Northing:** 1977587.597  
**Easting:** 1098392.973  
**Elevation:** 651.841 FT  
**Description:** 2.5" Alluminum Disk Stamped  
Village of Wheeling - Survey Marker  
**Location:** NE Corner of Camp McDonald Rd.  
Bridge over McDonald Creek, ~1250'  
W. of Wolf Rd.

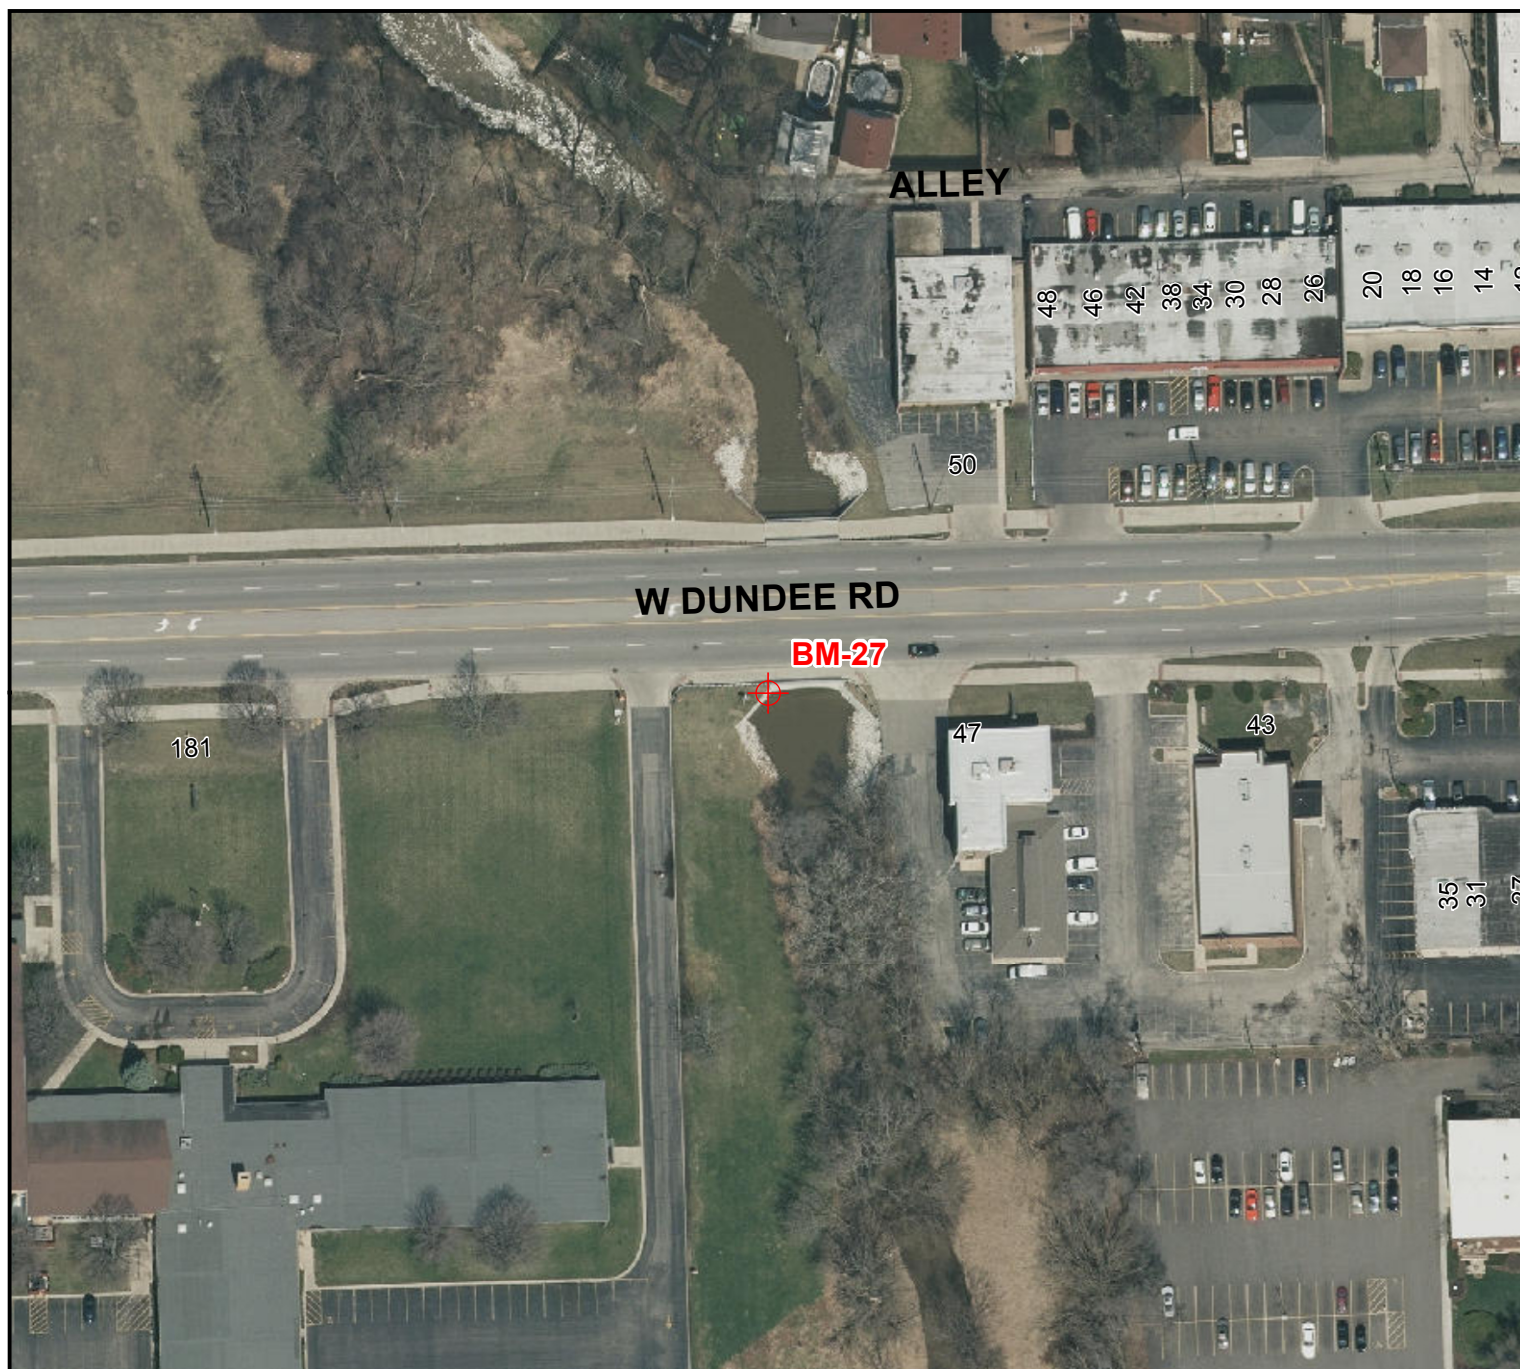
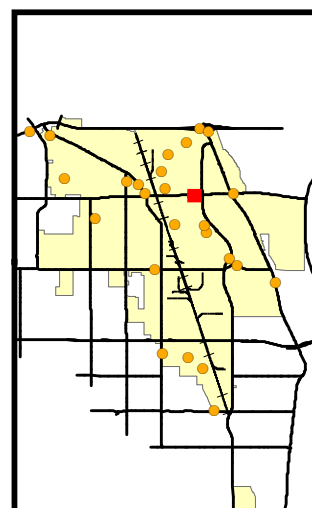
Benchmark BM-27  
Northing: 1993659.34  
Easting: 1096946  
Elevation: 647.098 FT  
Description: 2.5" Alluminum Disk Stamped

Location: SW Corner of the W Dundee Rd.  
Bridge over Buffalo Creek
